**Historic Building Assessment and Feasibility Study**

**Center Harbor Town House**

March 31, 2016  
**Revised - May 18, 2016**

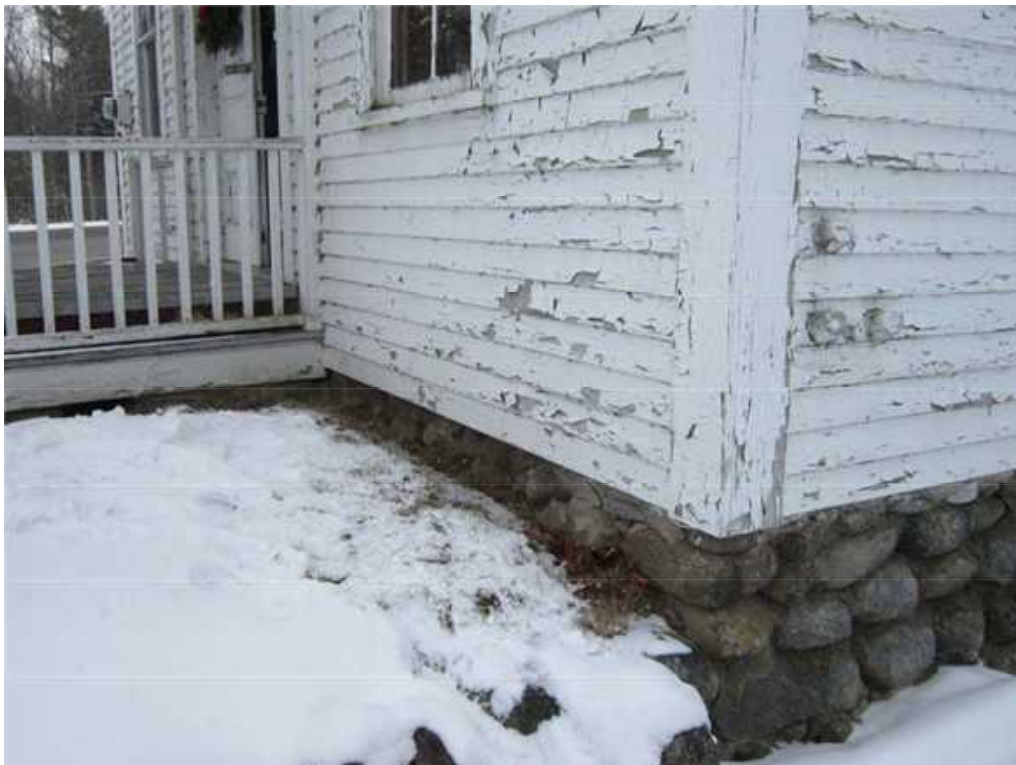
North east corner of main block showing extreme paint degradation and stone foundation

It is preferable to retain existing siding material and remove damaged paint finishes than to replace the siding wherever possible. On all areas of the north, east, and south elevations of the building where paint is peeling to bare wood, remove all remaining existing paint by hand and apply a quality latex primer and two coats of finish paint. On the west side, where the existing paint condition is better, painting preparation should be as appropriate for localized conditions. Painting in fair to good condition should be lightly sanded to assure that new paint binds adequately to the

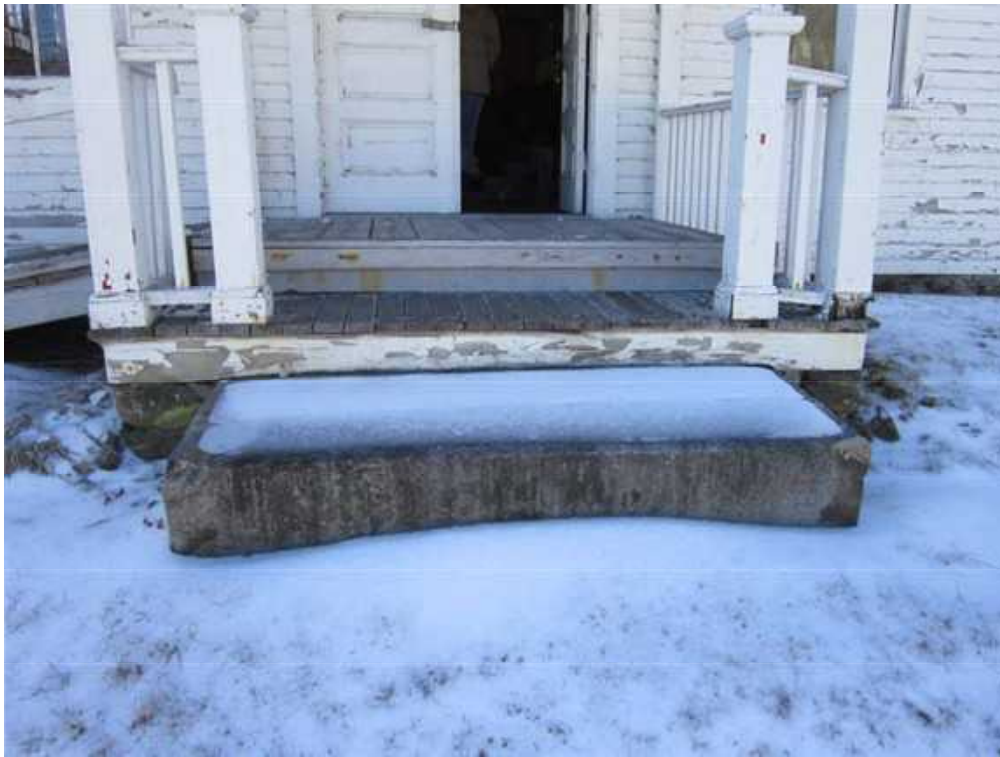
Porch floor is in very poor condition related to trapped moisture in the current assembly

It appears that the entry porch floor and the porch's corner columns require rebuilding because of water damage. The existing molded railings, balusters, and post trim should be carefully removed and set aside. The porch roof assembly is in good condition and should be supported in place while the existing ramp, the water damaged porch floor, and the porch frame are replaced. Use pressure treated pine with painted pine trim for the the porch floor and vertical grain douglas fir with a clear finish for the flooring. Coordinate foundation work described elsewhere in this report to be done in conjunction with the porch repair. Damage to the corner posts may be limited to the decorative base moldings only or may include damage to the structural post as well. To the highest degree possible, retain or reinstall original post materials. Once the posts are secure, fabricate additional materials to rebuild the railings to match the original intent. Regrade across the front of the building to provide good access to the reset stone step at the front of the porch.

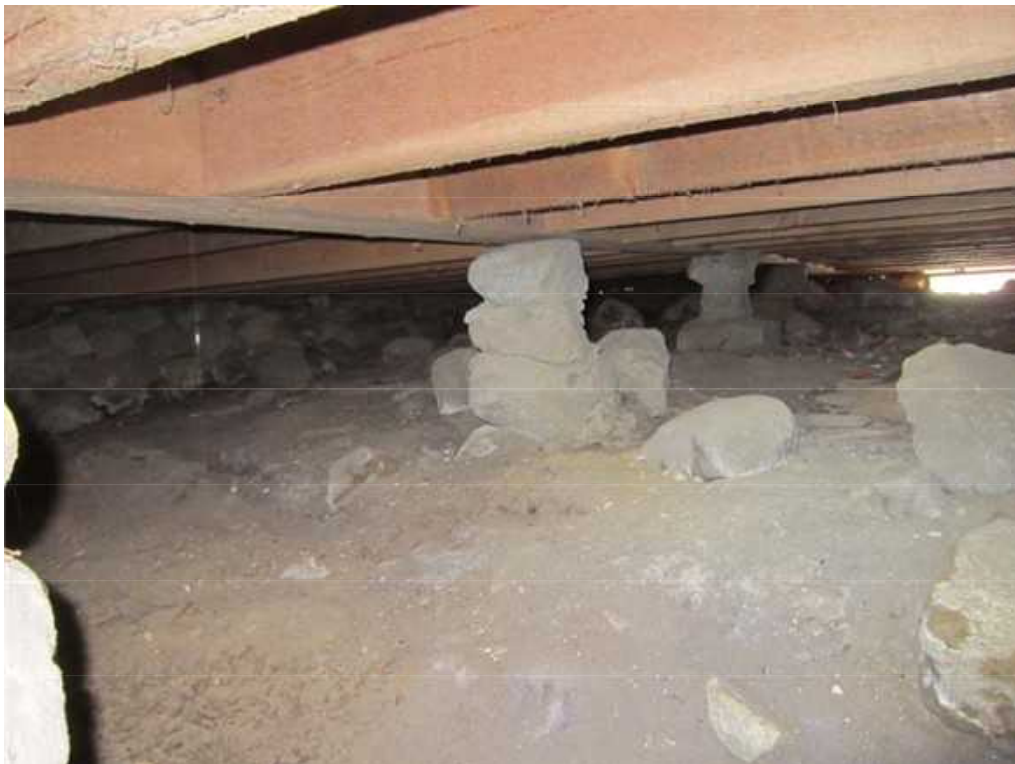
Existing crawl space with stone supports under beam - note proximity of floor framing to soil and complete lack of insulation in floor system above.

At the foundation level, there are significant additional challenges with the building structure that need to be addressed: moisture in the crawl space and frost action under the building's central piers. The following recommendations should greatly improve the building's current moisture problems. In the crawl spaces, all soil within 18" of the wood frame should be removed by hand (8" +/-). A vapor barrier should be installed over the dirt floor of the crawlspace, taking care to allow for a wide overlap and taping of all vapor barrier components under all structural work. Once the ground is covered, vents in the foundation should be rebuilt to allow them to be opened in the late spring and early fall and closed in the remaining seasons.

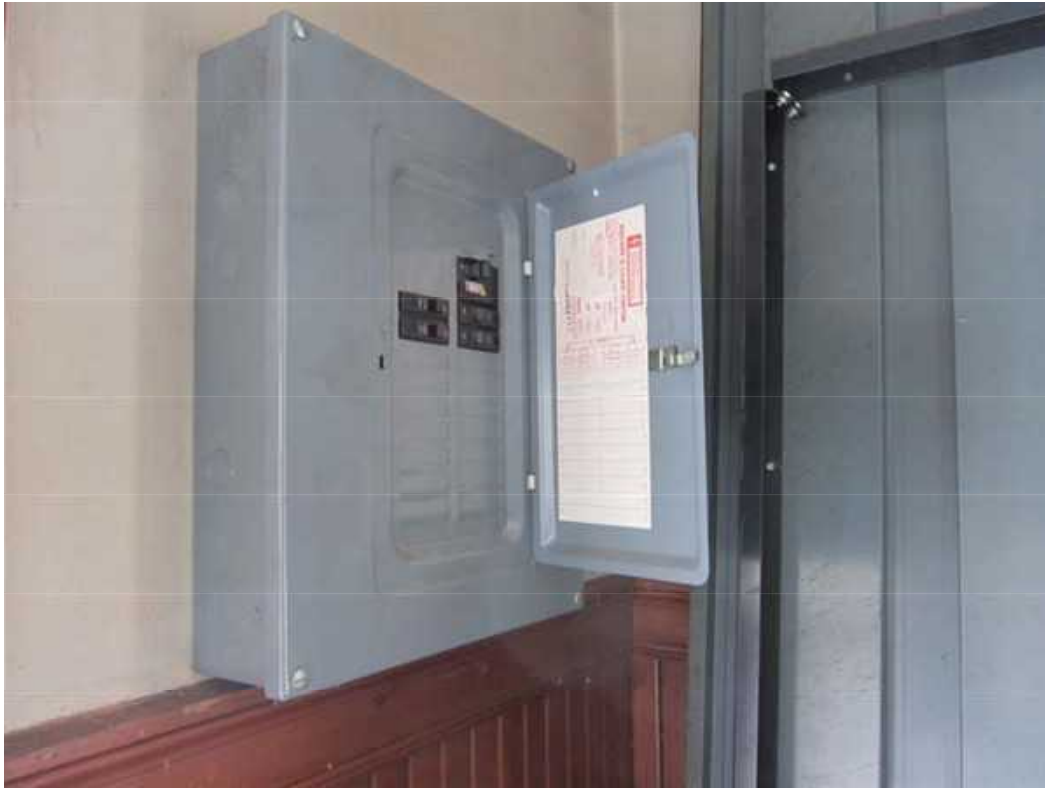
Circuit breaker panel. Most electrical work appears to have been updated in the 1980s, and other new wiring installed ad-hoc.

The existing electrical service to the building should be replaced to remove this fire hazard. The service panel should be inspected and made safe by an electrician, who can remove and replace any deteriorated wiring or remaining ungrounded circuits. Unused wiring from previous repairs should be pulled and removed from the building. New LED lighting in warm color should be installed to augment lighting levels without changing the lighting patterns. The Center Harbor Energy Committee has expressed an interest in providing assistance with energy related issues with the Town House.

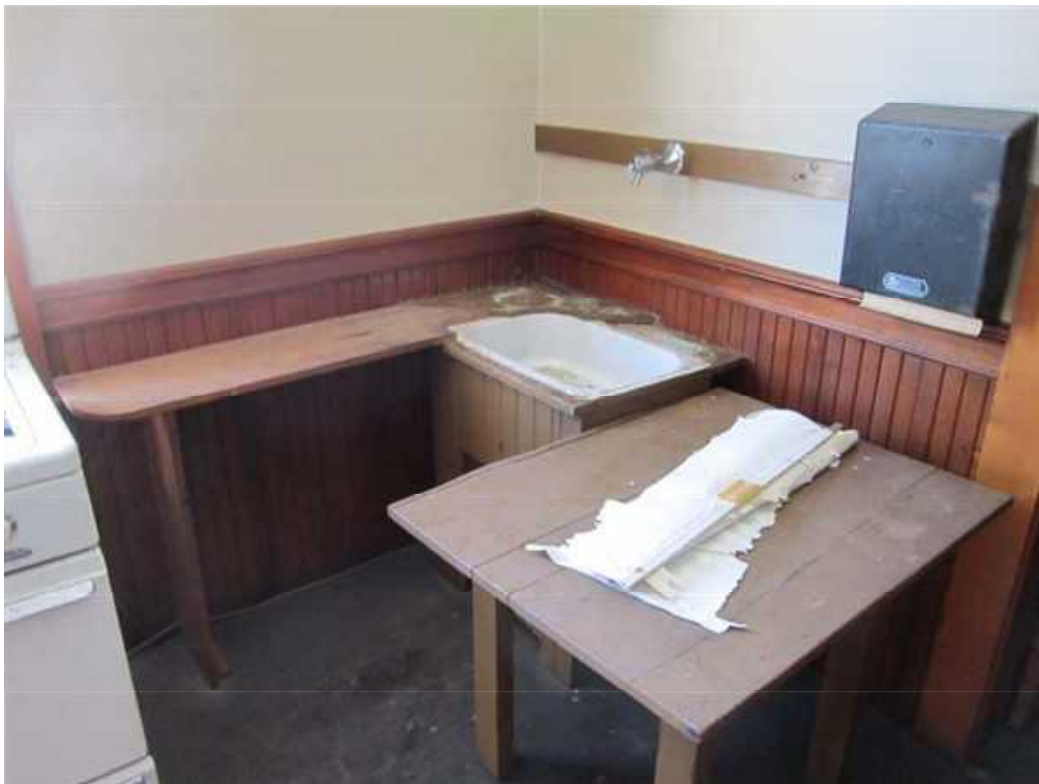
Makeshift kitchenette in southwest corner of stage area has no running water

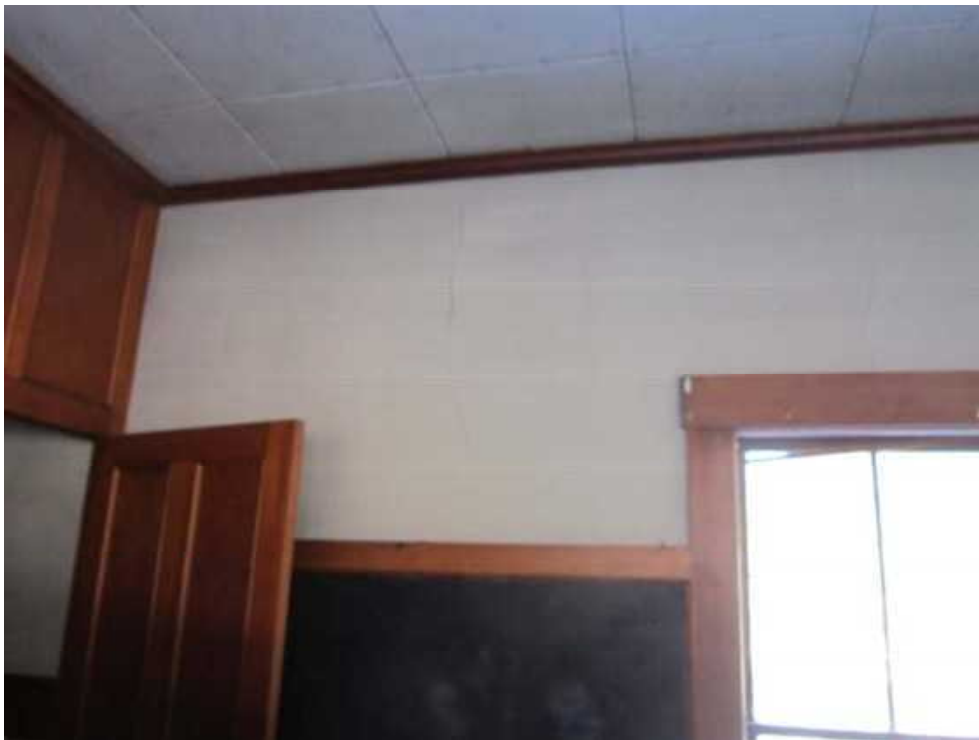
Minor cracking of plaster typical of foundation movement under frost action.

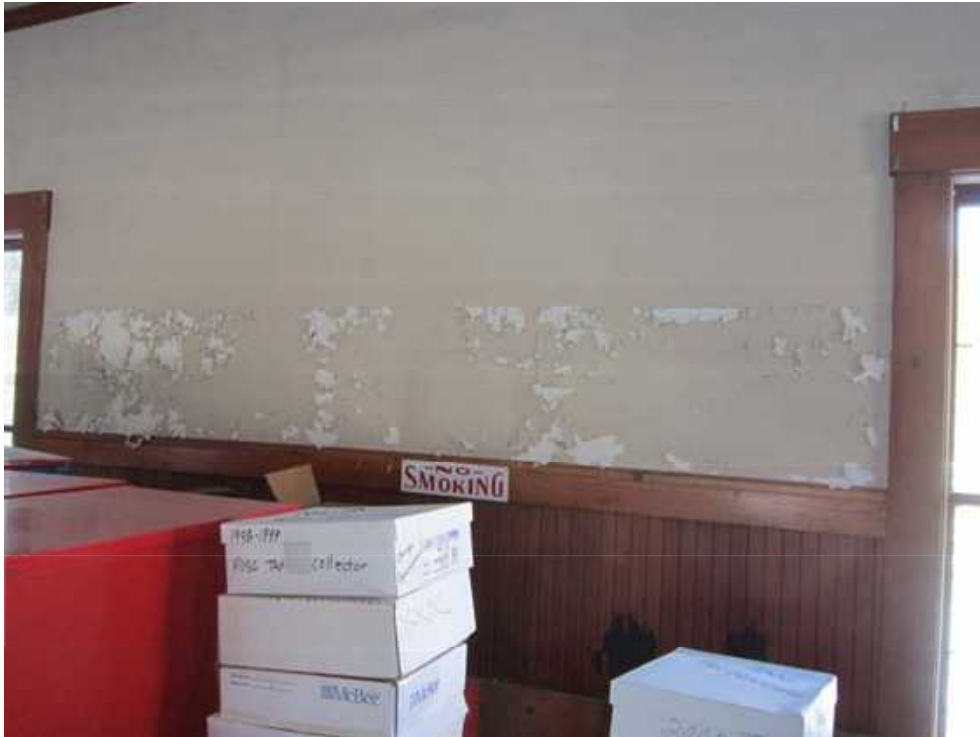
Localized area of paint failure behind where chalkboard or bulletin board was previously removed

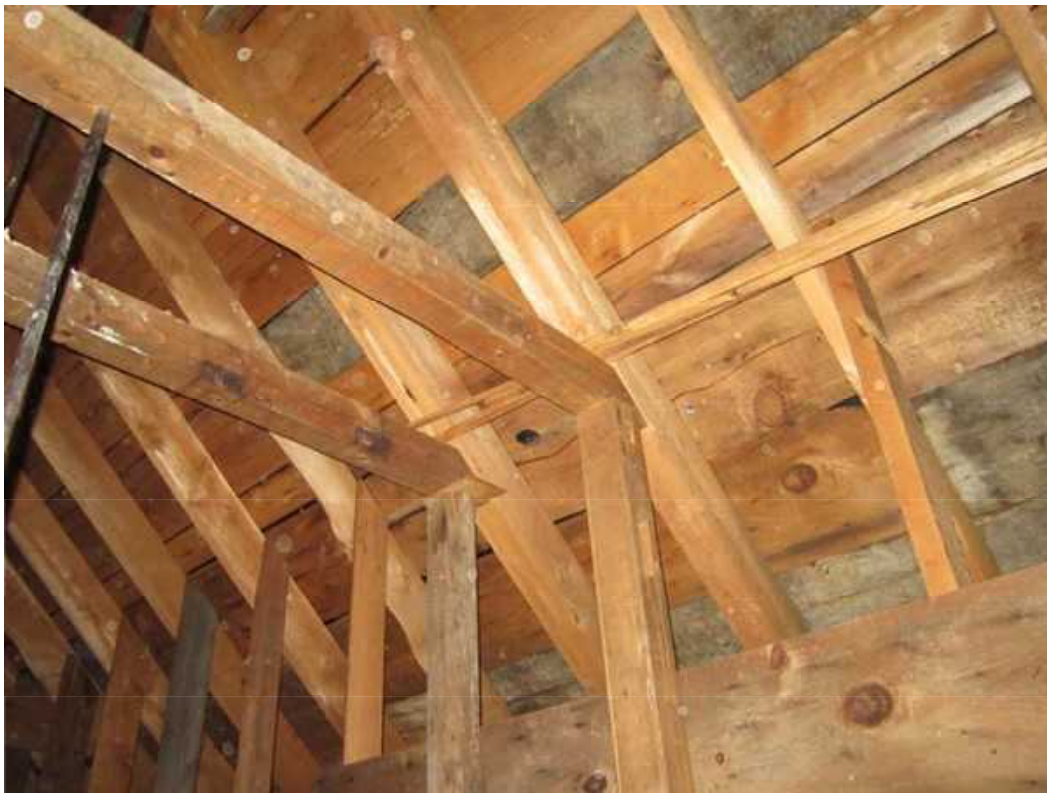
Attic with sawn common rafters. Additional framing to left was apparently added for lateral support of recently removed hanging chimney at center of meeting hall.

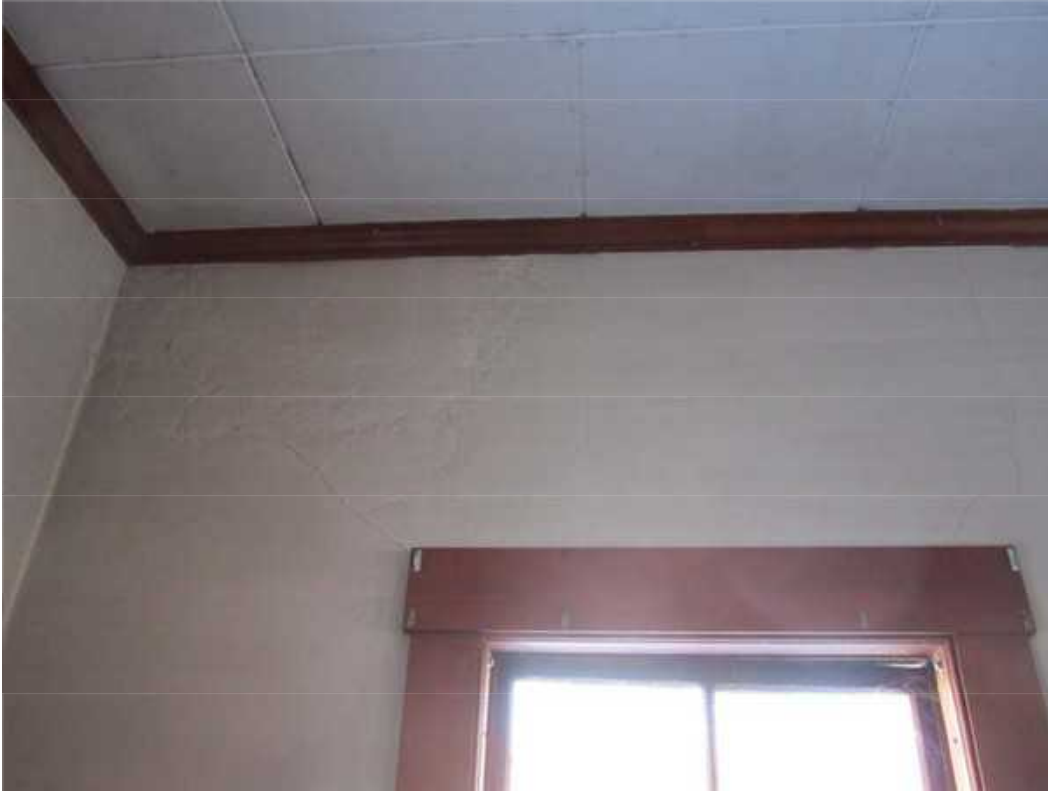
Stress cracks in plaster work have been previously repaired at northeast corner of meeting hall

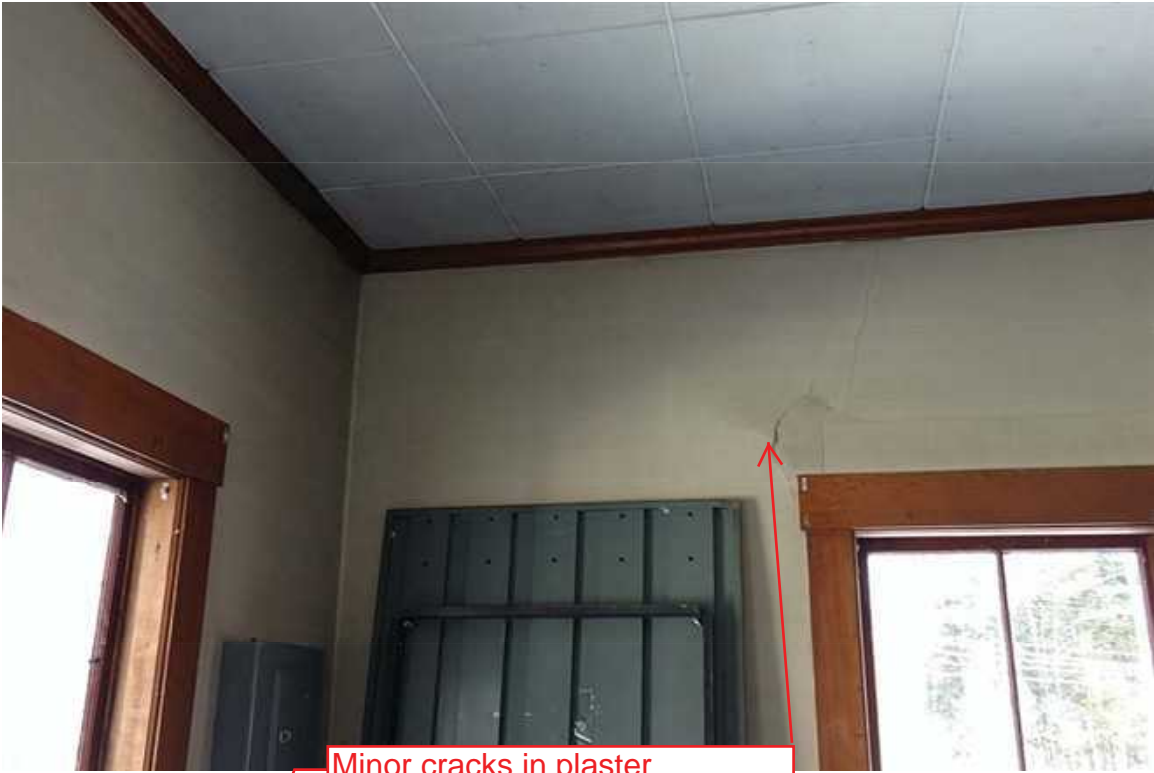
Minor cracks in plaster  
indicating foundation movement
