INDIVIDUAL INVENTORY FORM

NHDHR INVENTORY # CEN0010

1. Historic name Center Harbor Village School
2. District or area _____
3. Street and number 94 Dane Road (25B)
4. City or town Center Harbor
5. County Belknap
6. Current owner Town of Center Harbor

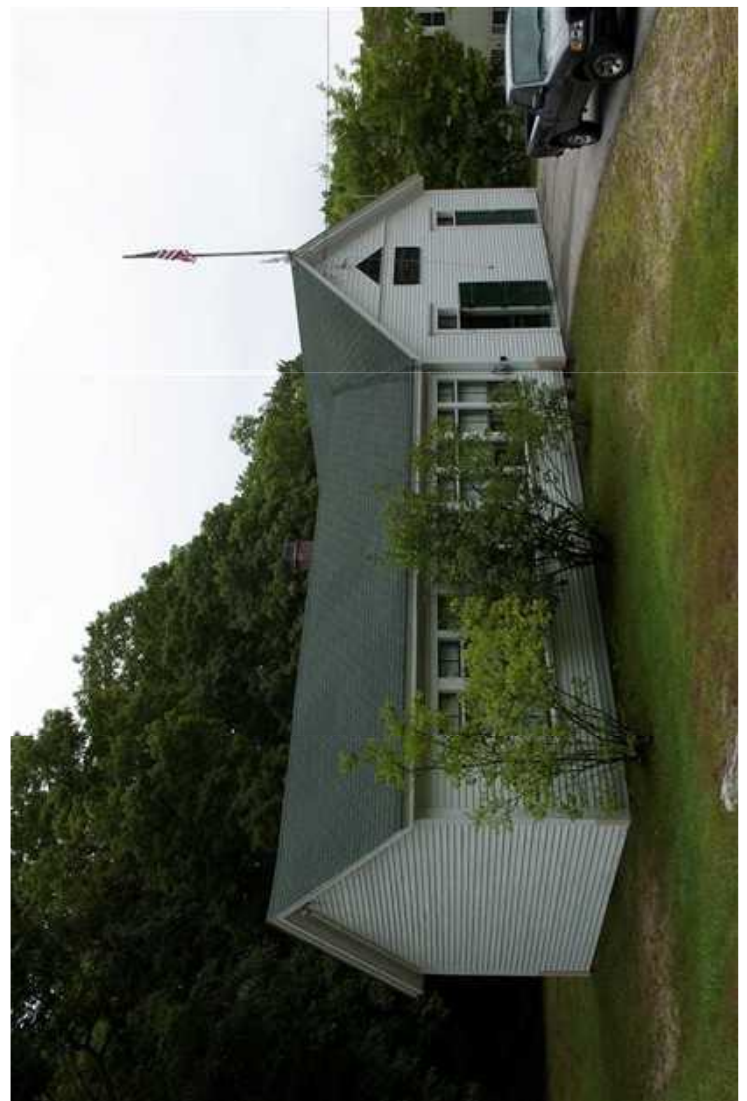
35. Photo #1 Direction: Southeast
36. Date August 13, 2016
37. Reference (file name or frame#): DSC_0044.NEF

The 1886 main block is Queen Anne in style. (Photo 1 & 2) It is one story with symmetrical gable-end facing the street. The roof is covered in asphalt shingles. A rustic flag pole is located at the gable-end and constructed of a small tree-trunk. Slightly behind it, is a decorative wooden finial. A brick chimney with decorative cap is located at the rear end of the gable. The roof has a modern overhang with open rake and enclosed rafters. The narrow fascia is flat and decorated by a shingle molding.

The main block sits on a brick foundation. This foundation is supported by a mortared field-stone underlayment at the northeast corner of the building. The asphalt driveway is built-up at the primary façade, overlapping some of the building sheathing. The crawlspace beneath the structure is vented through a small opening at the midpoint of the southeast side.

The wood frame is sheathed in wooden clapboard siding. There is a piece of half-round trim above the first-floor level at the primary façade, creating a belt across the gable end. The area above this trim is sheathed in decorative rows of shingles with fish scale, staggered, octagonal and square imbrication patterns. Other building trim includes narrow frieze board and narrow flat corner boards.

The fenestration of the primary façade is symmetrical. Two doors are located at the façade. The door surrounds are identical for each door, with narrow flat jambs. A slightly recessed transom window is located above each door, below a heavy decorative crown. The door at the northwest is six-panel and that at the southwest is four-panel. There is a triangular fixed sash at the gable end that is made up of six lights.

Along the southeast side of the building are several window units, each composed of a two-lite fixed sash above a 2/2 window within a flat frame with decorative crown. There is a single window unit at the southwest with three paired window units to the east.

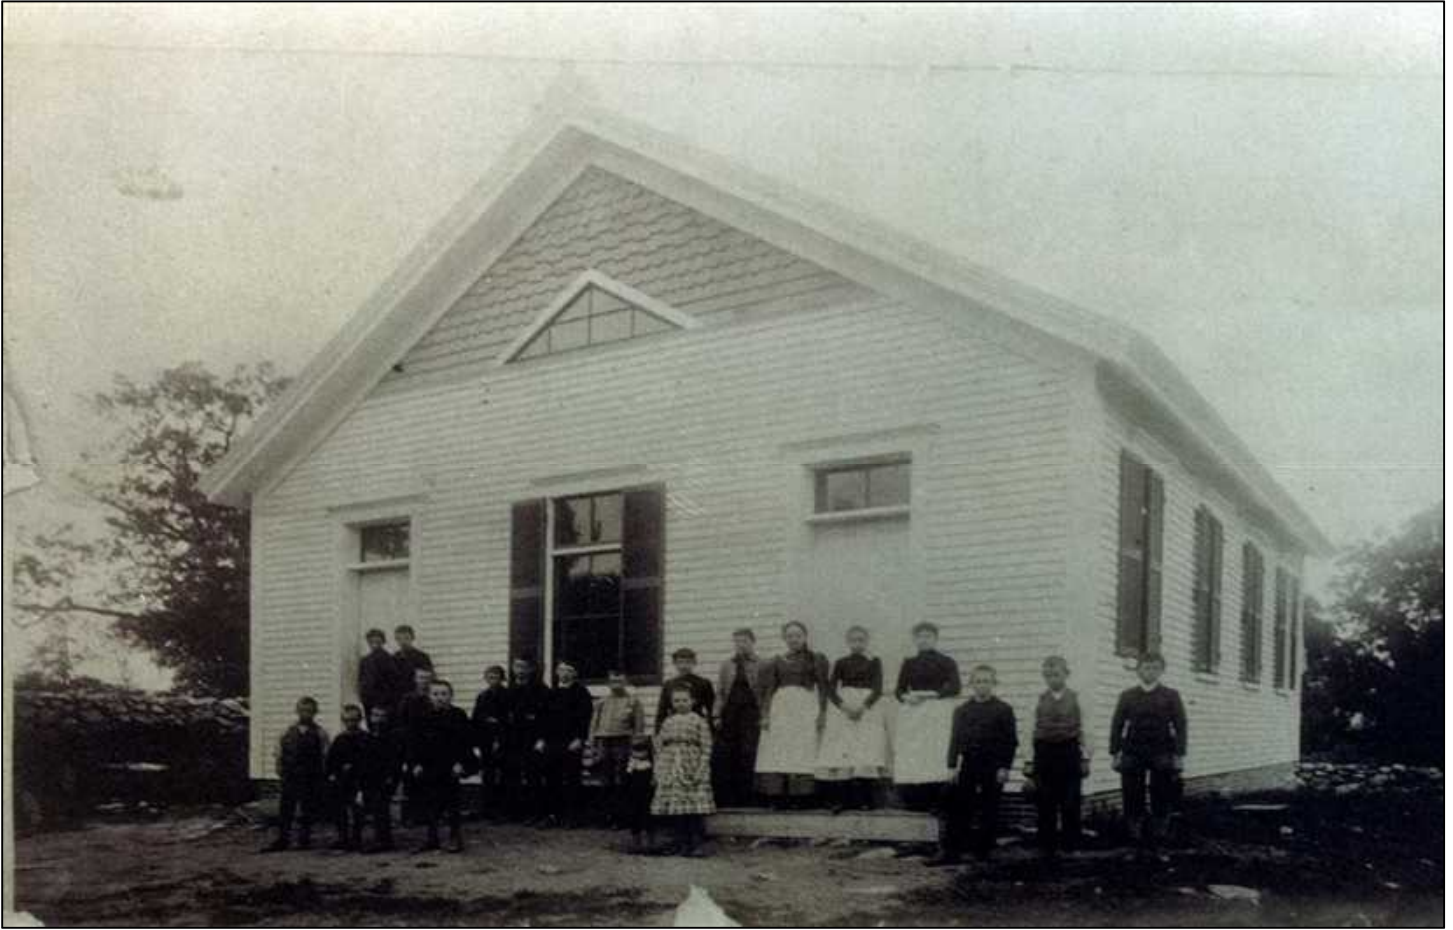
Figure 3: Center Harbor Village School, c. 1900

When it was constructed in 1886, there was a center window at the primary façade, between the doors. (**Figure 3**) This window was removed in c. 1929. Early photographs of the building show a single wooden step beneath each door, dark window shutters, and a contrasting paint color in the gable-end. By 1902 the steps were rebuilt, creating a wide set of four steps between the two doors and the flagpole was added. (**Figure 4**) By the 1940s, these steps had been replaced by a large open porch. (**Figure 6**)

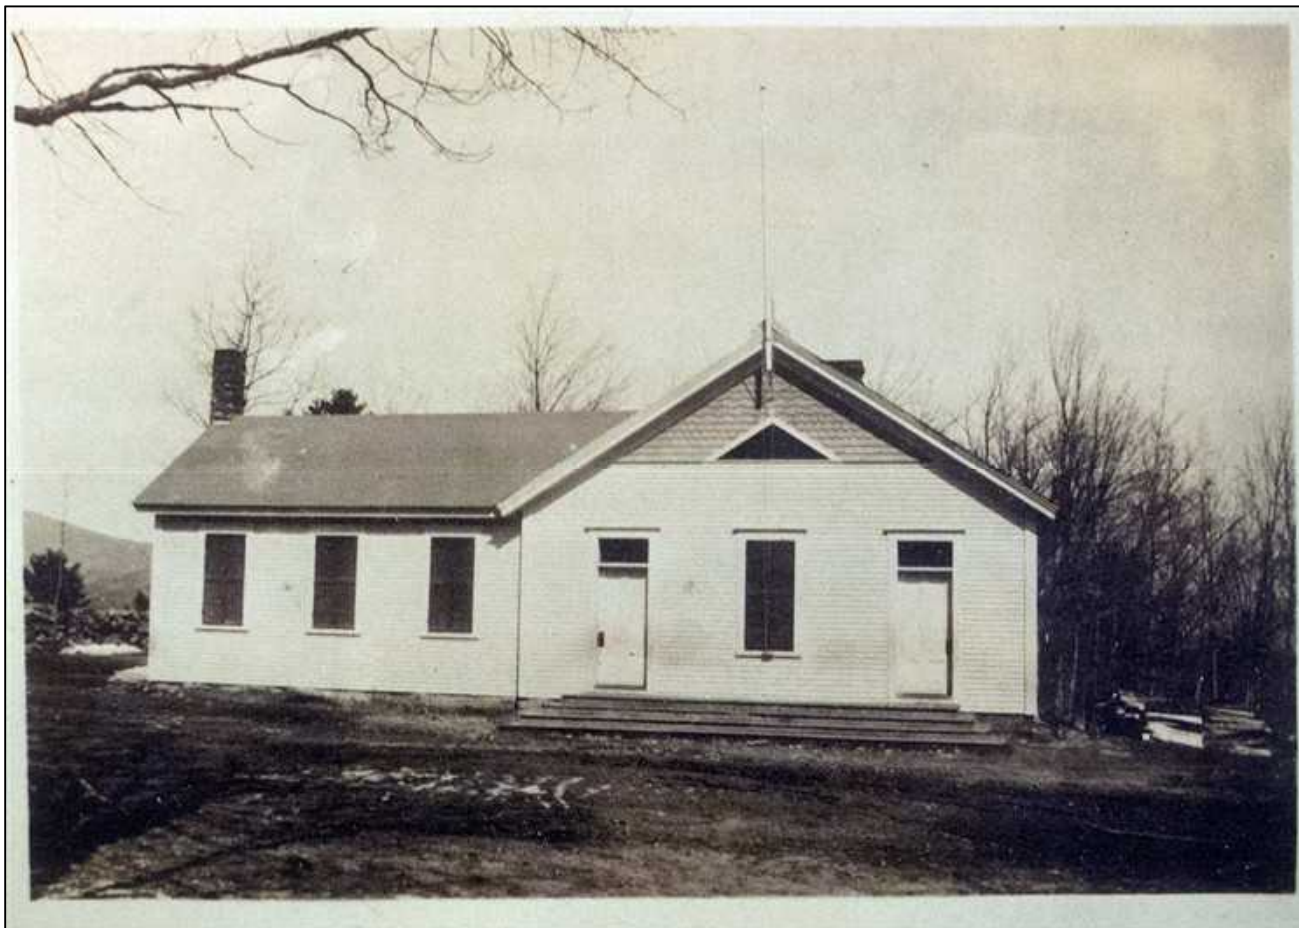
Figure 4: Center Harbor Village School, c. 1902

The first major alteration to A. L. Davis' design came in 1902, when a secondary classroom was added off of the northwest side of the original structure. (**Figure 4**) This classroom allowed for the single room to be separated into a Primary Department (with 20 students) and a Grammar Grade (with 19 students), creating a more age-specific learning environment.²² This first addition was three bays long and had a chimney at the north end of the gable roof. Lumber for the addition was supplied by James P. Leighton²³ and the addition was constructed by Fred. E. Webster, who was paid \$300 for his labor and \$72 for desks.²⁴

The southern section of this ell was added in 1902 as a three-bay addition. (**Figures 4 & 5**) This addition had a chimney at the north end and was used as a second classroom. In 1929, the addition was extended to its present size. The windows were replaced and the chimney was removed. In c. 2015 a protective overhang was removed from over the exterior door by the Historical Society in an effort to mitigate rot issues.

Center Harbor Village School shortly after 3-bay addition to the north.

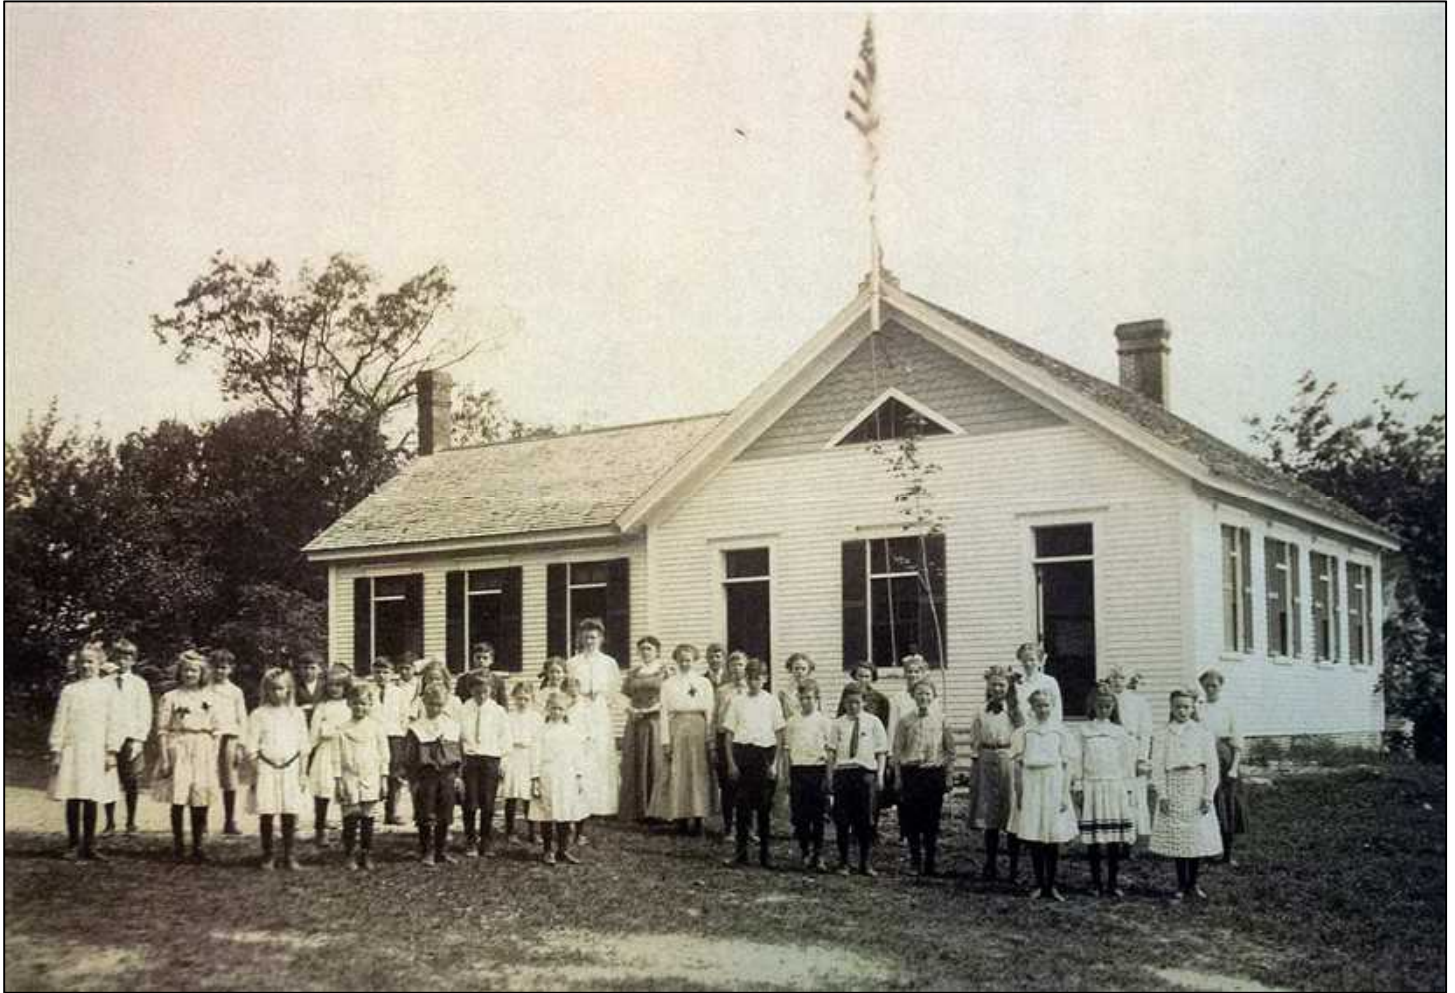
Figure 5: Center Harbor Village School, c. 1920

In 1919, the Moultonborough District No. 18 school combined with the Center Harbor Village School. (**Figure 5**) The Village School now accommodated children from Moultonborough, Center Harbor Neck, Center Harbor Village and Garnet Hill. While it shared the second classroom, Moultonborough paid the salary of a second teacher. The teacher of the Grammar Room received \$6/week and the teacher of the Primary Room \$5/week.²⁵

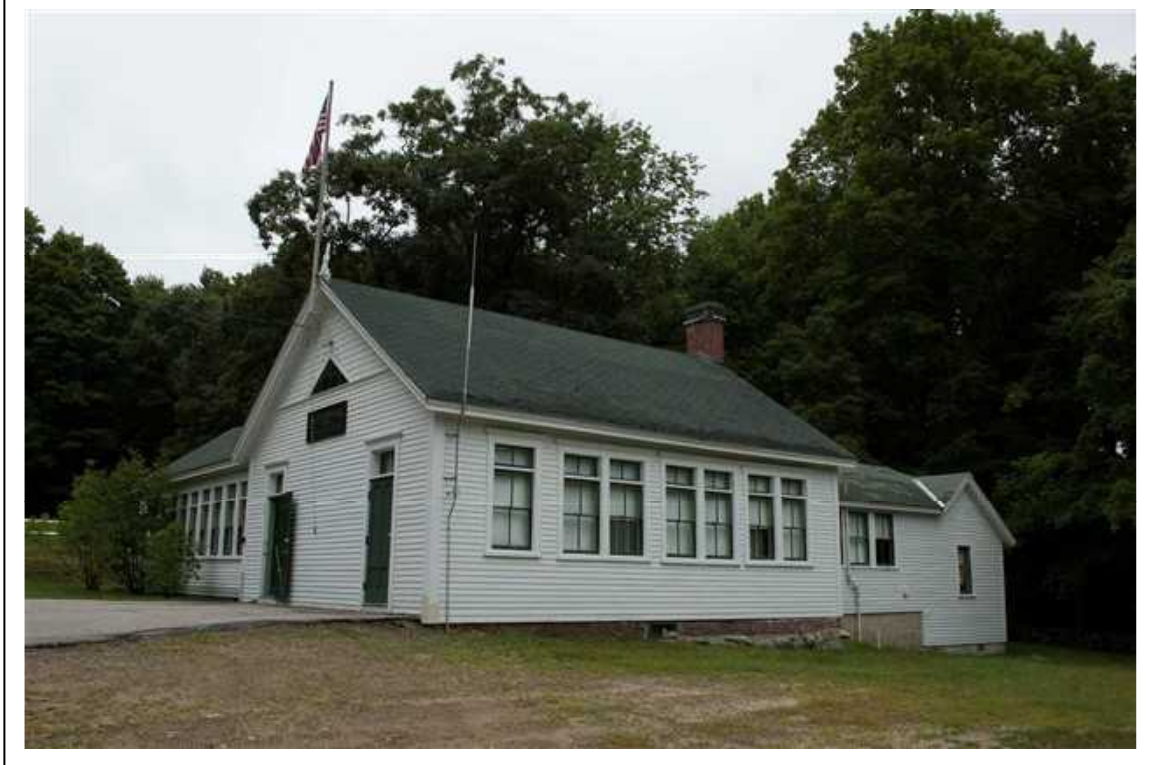
There is a long addition off of the southwest corner of the main block. (Photo 2, 3, & 4) Like the main block, this addition has an asphalt shingle roof and clapboard siding. The foundation of the addition is concrete. Here, the window units have been set in a contiguous band of nine windows across the southwest side. There are three two-lite louvered windows at the northeast elevation, just below the roof. A doorway is located at the northeast corner of the ell. The historic door has been replaced with a modern single-panel door.

Photo # 2 Description: Left to right: classroom addition, 1886 school, kitchen, and "workroom."
Reference (file name or frame#): DSC_0055.NEF Direction: North

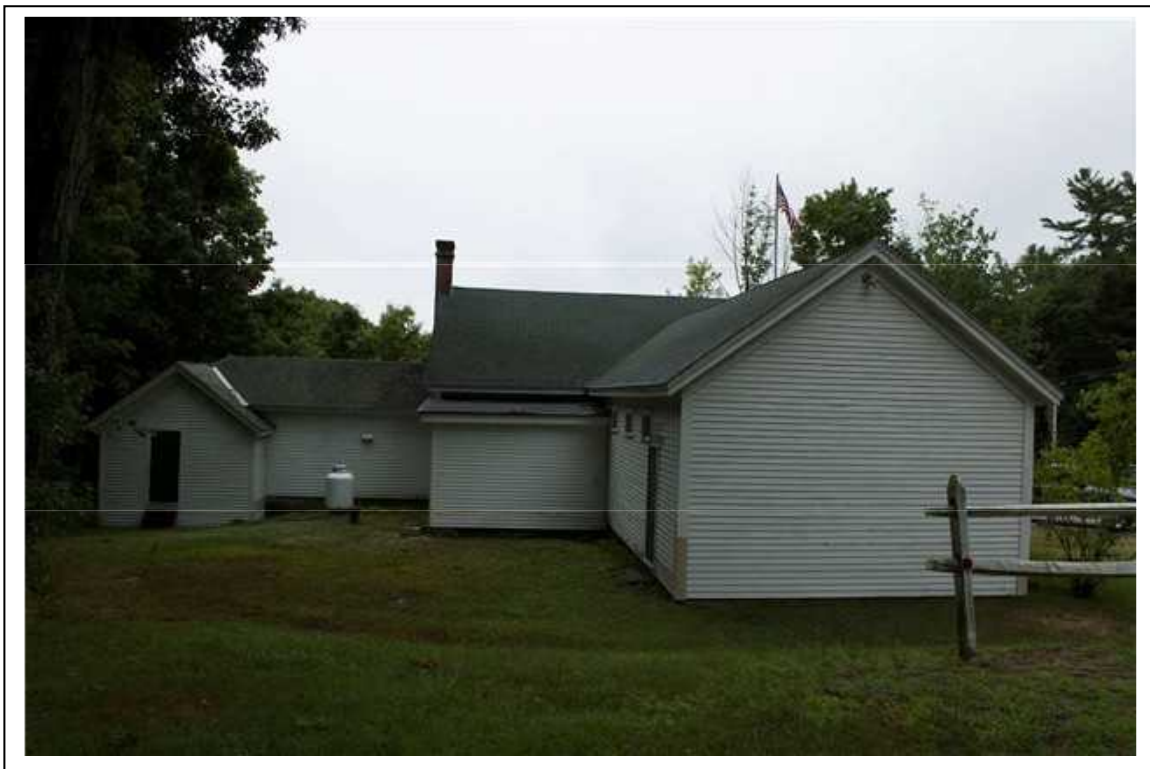
There is a 1921 shed addition off of the east side of the ell. (Photo 3 & 4) When it was built in 1886, the original Schoolhouse had a privy and woodshed, but the location of this detached structure(s) is unknown. The shed has no

A wing addition is located off of the northeast end of the 1886 building. (Photos 3, 4, & 5) This was added in 1929 for use as a kitchen. Like the classroom addition, the kitchen sits atop a concrete foundation. There are three 2/2 windows on the south side, and no windows to the north.

Photo # 3 Description: Left to Right: "workroom", kitchen, shed (1886 school behind), classroom addition.
Reference (file name or frame#): DSC_0046.NEF Direction: Southeast

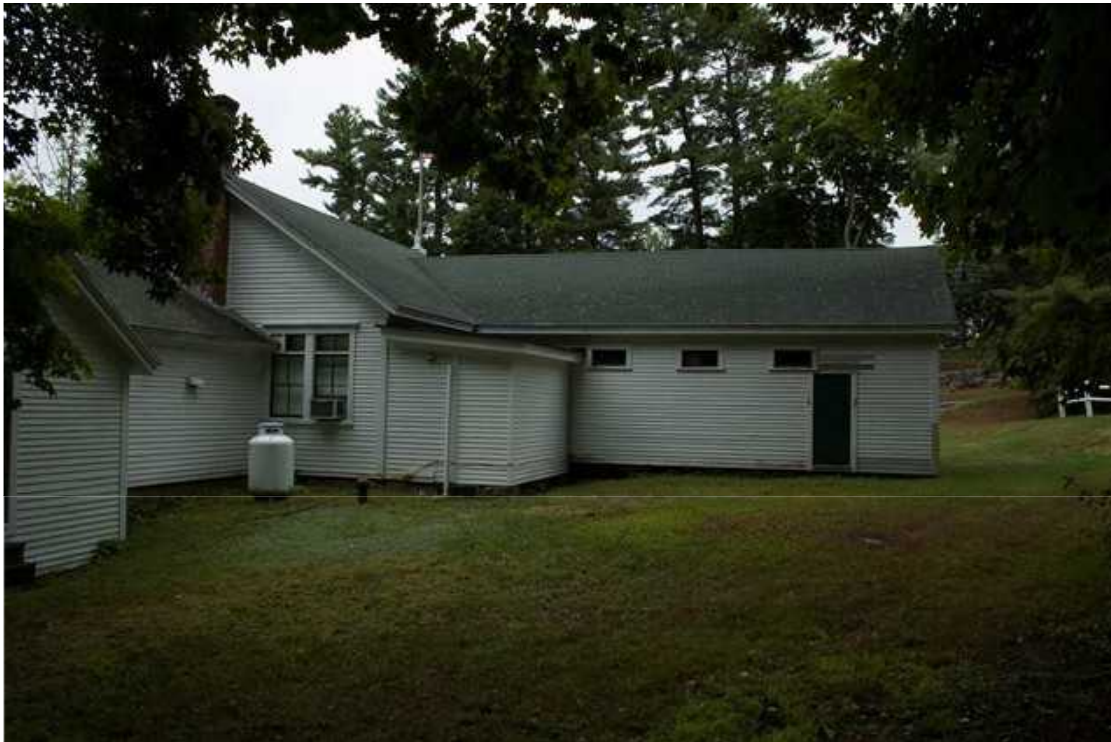
Photo # 4 Description: Left to right: "workroom", kitchen, 1886 school, shed, classroom addition.
Reference (file name or frame#): DSC_0050.NEF Direction: Southwest

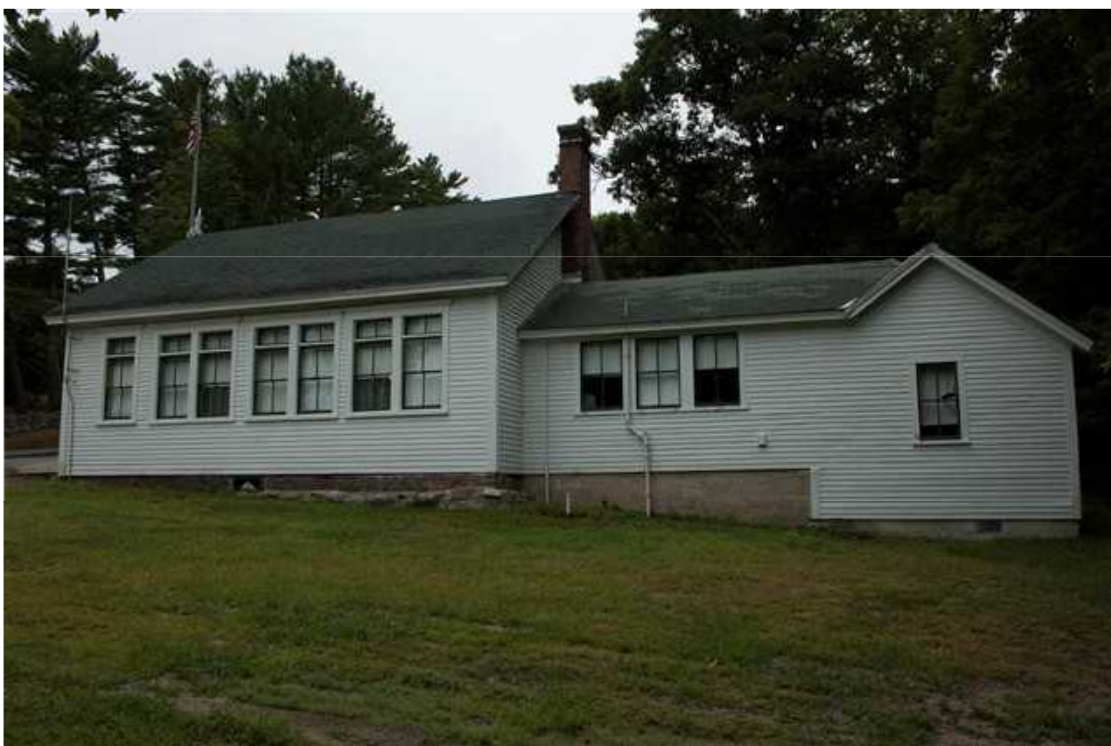
The final section of the Center Harbor Village School is an off of the northeast end of the kitchen. (Photo 5) This is commonly referred to as the "Workroom" and was originally used as a woodshed. The workroom has a concrete block foundation, and clapboard sheathing. The structure has four lite single-sash windows. The date of the workroom is unknown and may have been constructed in 1902, when the first addition was made to the School. It does not appear in early images of the building, but is shown in a photograph that was taken c. 1920. **(Figure 5)** Most-likely this building originally served as either a privy, or, more-likely, as a woodshed.

Photo # 5 Description: 1886 School at left, kitchen at middle, "workroom" at right.
Reference (file name or frame#): DSC_0053.NEF Direction: Northwest

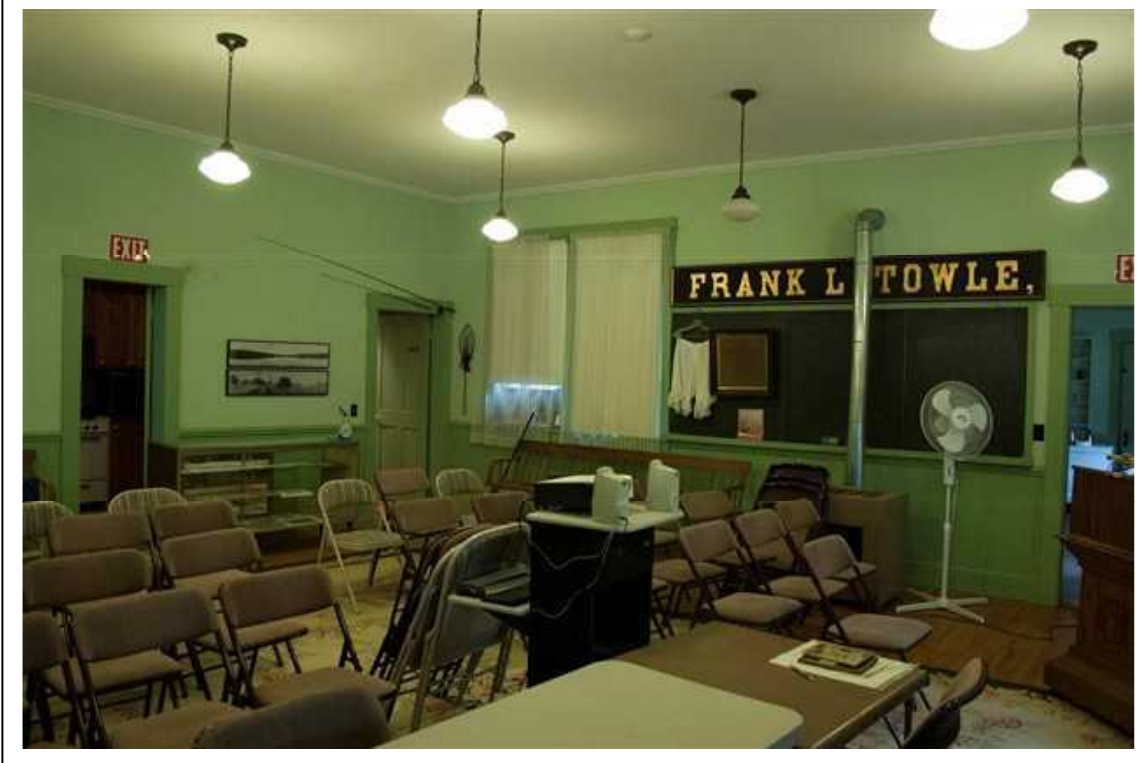
The 1886 classroom has vertical bead-board wainscot, picture rail, and plain flat trim around doors and windows. (Photo 6) There are chalk boards along the northeast and southwest walls, with built-in chalk ledges. (Photo 7) The room is lit by c. 1925 ceiling fixtures and there is a modern gas-fired heater at the center of the northeast wall.

Photo # 6 Description: Interior of 1886 classroom.
Reference (file name or frame#): DSC_0019.NEF

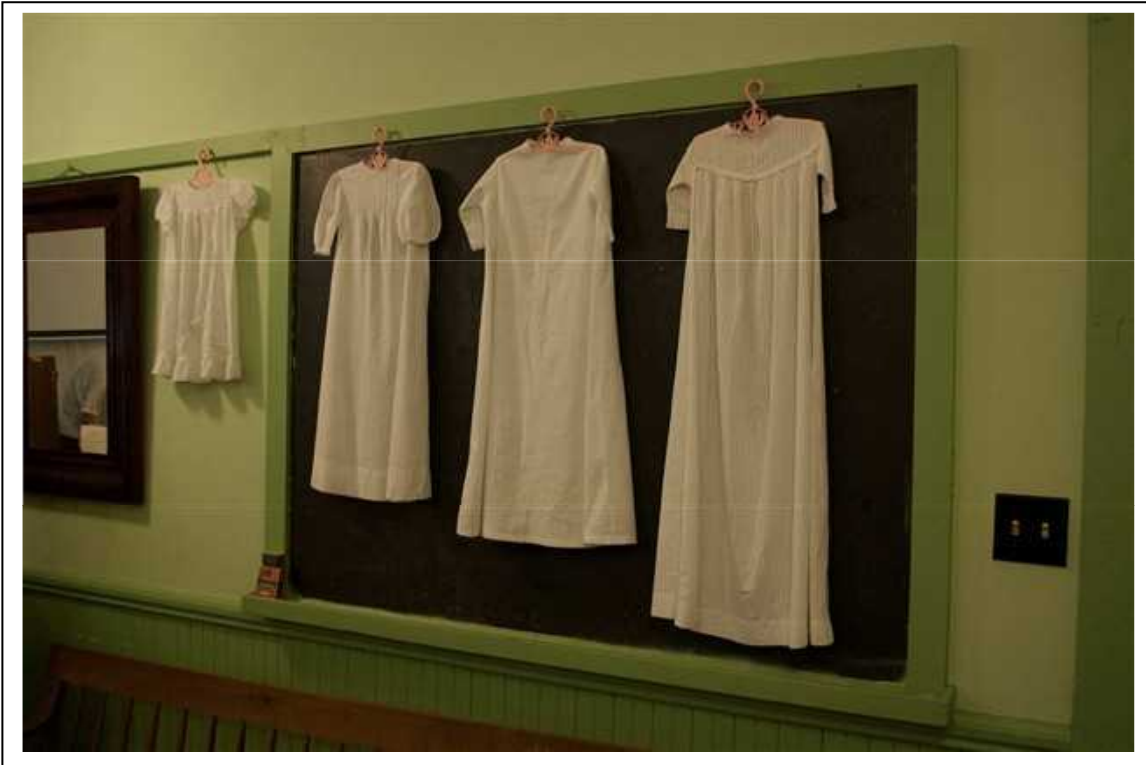
Photo # 7 Description: Chalkboard detail, 1886 classroom.
Reference (file name or frame#): DSC_0023.NEF

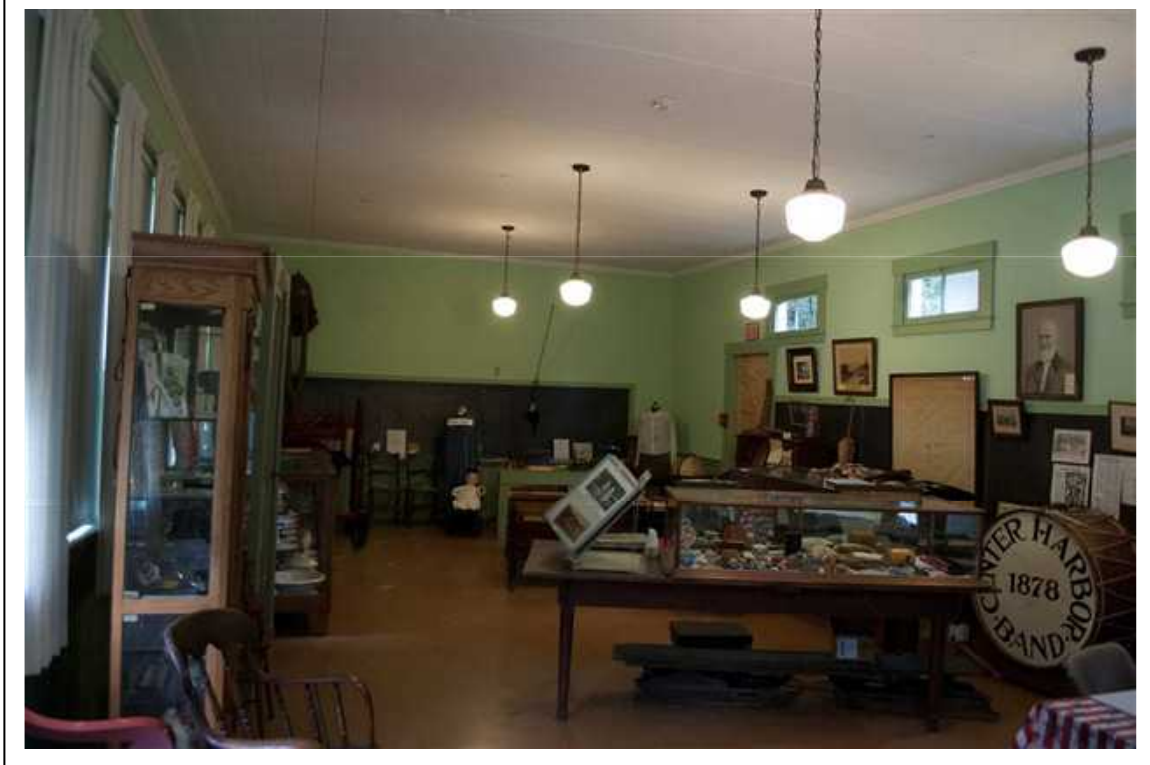
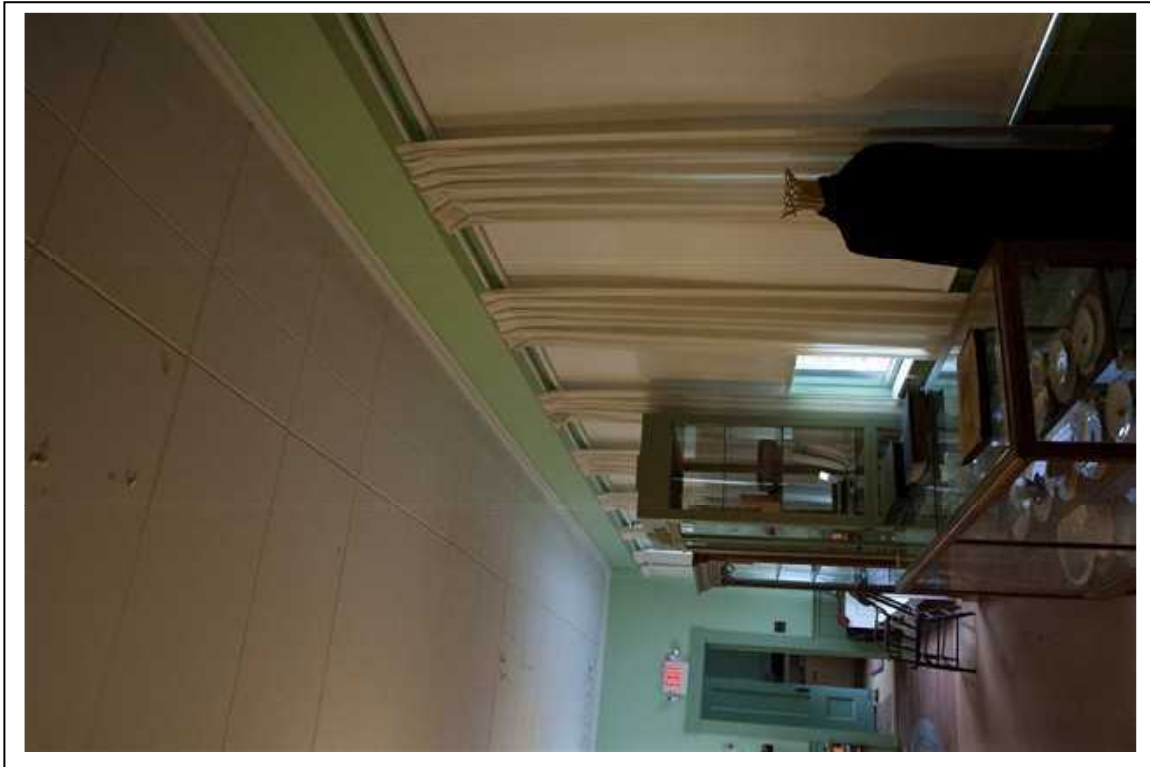
The interior of the 1929 classroom, in the ell, is somewhat similar to the 1886 classroom. (Photos 8 & 9) The walls of this room are plaster, with bead-board wainscot and picture rail. There are also built-in chalkboards in this room and slightly later period light fixtures hanging from the ceiling. The room has a concrete floor that is covered in sheet linoleum. The ceiling of this room is composed of paneled fiberboard (possibly Masonite, which was popular in the late 1930s and 1940s).

Photo # 8 Description: Interior of classroom addition.
Reference (file name or frame#): DSC_0039.NEF

Photo # 9 Description: Interior of classroom addition.
Reference (file name or frame#): DSC_0042.NEF

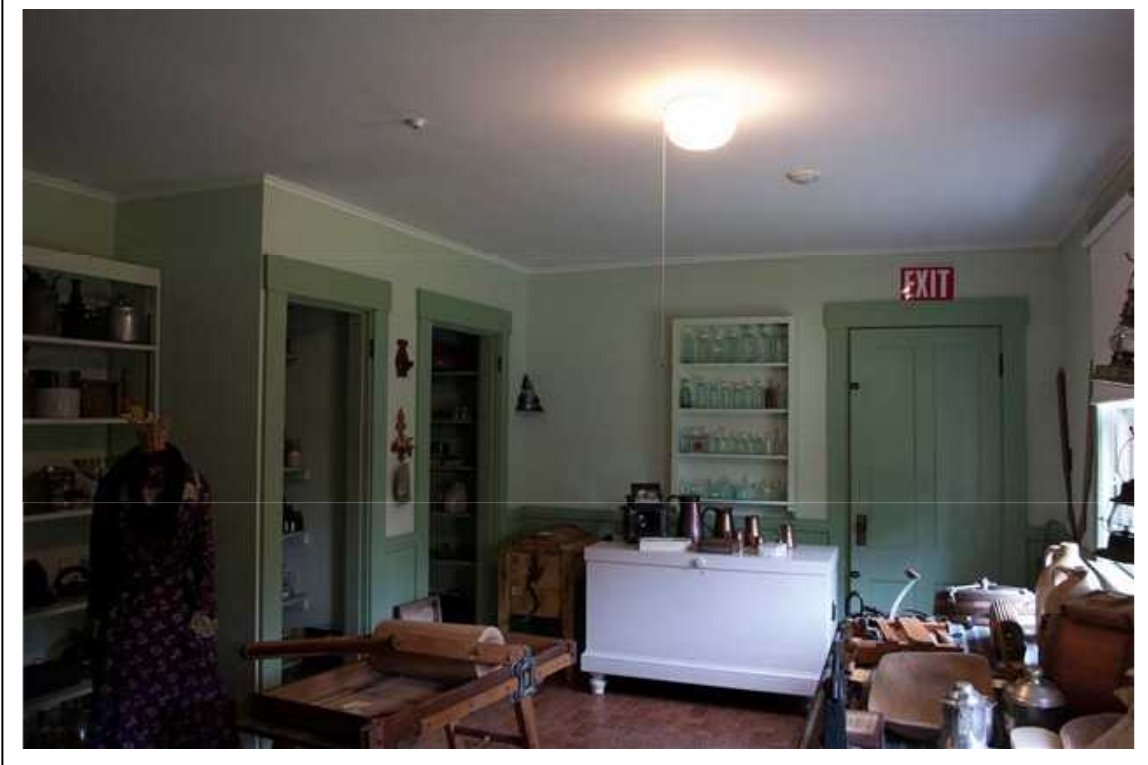
The 1929 kitchen wing has plaster walls and ceiling, beadboard wainscot and picture rail. (Photo 10) This room has a linoleum floor. There is a chimney at the southwest side of the room which has been partly plastered over. Stove flues are visible in this chimney. An additional exterior vent is visible at the center of the northwest exterior wall, indicating the location of a former gas or electric stove. There are two storage closets at the north corner of the room.

Photo # 10 Description: Interior of Kitchen, facing door into "Workroom"
Reference (file name or frame#): DSC_0024.NEF

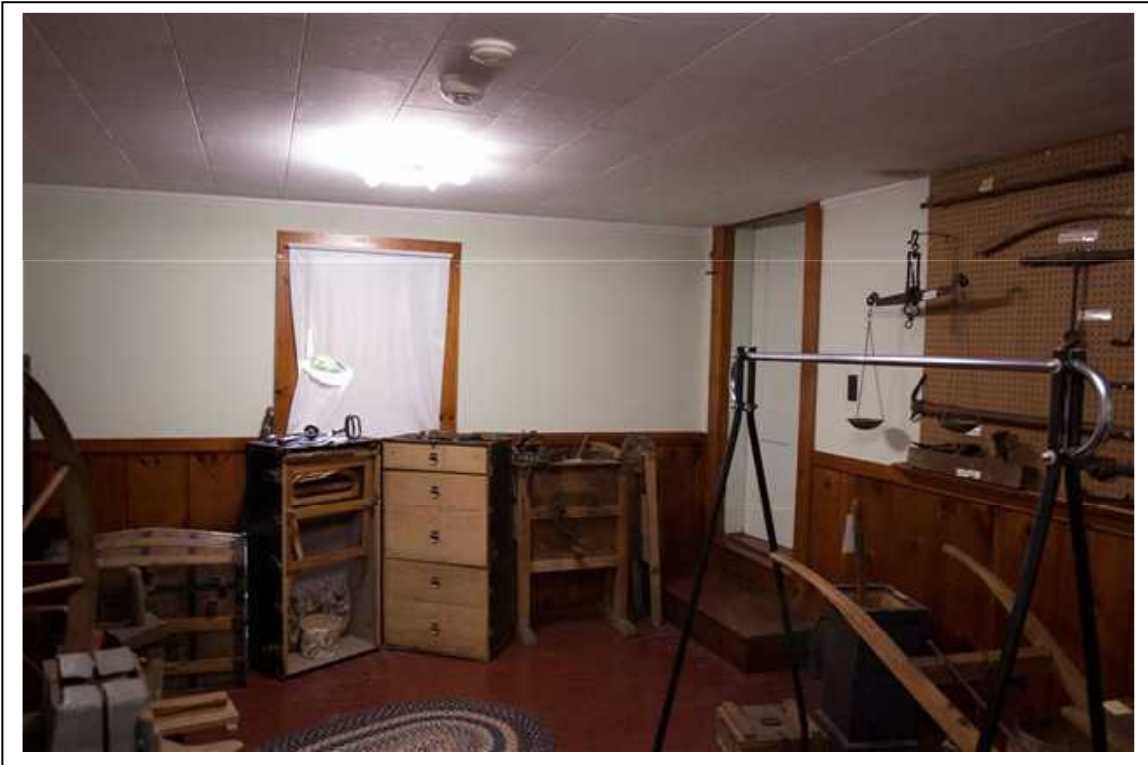
The interior of the "workroom" is very different from the rest of the Village Schoolhouse. (Photo 11) This room has a pine floor, knotty-pine wainscot, sheetrock walls, and fiberboard tile ceiling. The interior treatments of this section of the building are mid-20th century, and suggest that this room was once unfinished space.

Photo # 11 Description: Interior of "Workroom" facing door to Kitchen
Reference (file name or frame#): DSC_0034.NEF
