**Historic Building Assessment and Feasibility Study**

**Center Harbor Town House**

March 31, 2016  
**Revised - May 18, 2016**

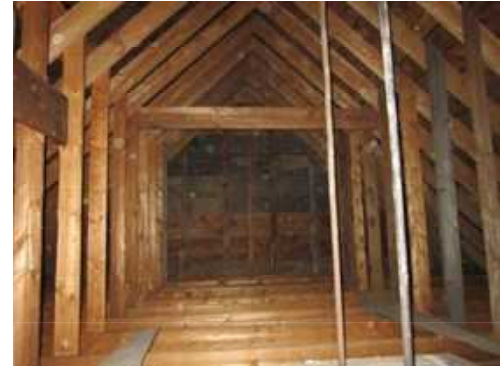
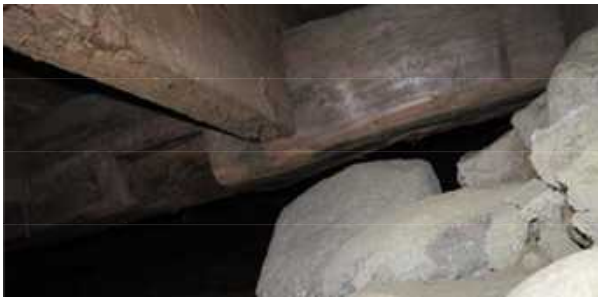
The building frame of the Center Harbor Town House is almost entirely of sawn common softwood with 4" deep balloon-framed exterior walls and a roof assembly of 2" x 7" rafters overlain with board sheathing. The floor frame of the original Town House is composed of recycled hewn timber sills and floor girts across the short dimension of the building at approximate 10' intervals. The floor beams support 1 ¾" x 10 ¼" wood floor joists and bear intermittently on piles of large, loose stones. The specific condition of the floor frame was difficult to evaluate because the crawlspace was inaccessible, but what could be seen seemed in sound condition and the floor feels firm for a building of this age and limited recent use. Structural review by the structural engineer concludes that the joists are appropriately sized but the heavy

notching at their ends make them unacceptably susceptible to splitting. The timbers were determined to be the weak link in the floor system and are only sized to support about half of the 100 lb/s.f. loads required by the NH state building code. The proximity of the floor frame to soil in the shallow crawl space is a cause for concern and the floor frame may be deteriorated from long term exposure to unacceptably high moisture conditions

All of the building's timber sills should be inspected at the time of siding repair and replaced if damaged by insects or rot. At the first floor platform level, the floor joists should be re-supported with a continuous ledger or joist hangers to eliminate structural overstrain on the notched joist ends. The hewn timber beams supporting these joists could be seen at a distance during the inspection. Recommendations for improving their performance up to code standards is discussed in the section following on Foundations. With no way to get into the crawl space, a thorough exam of the condition of the frame was impossible. The proximity of the exposed soil to the frame members is a cause for concern related to high moisture levels. Elements of the framing should be inspected and any materials damage by moisture or rot should be replaced.

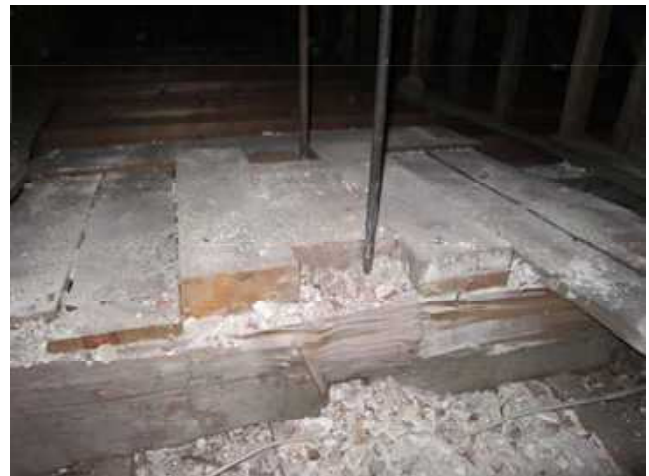
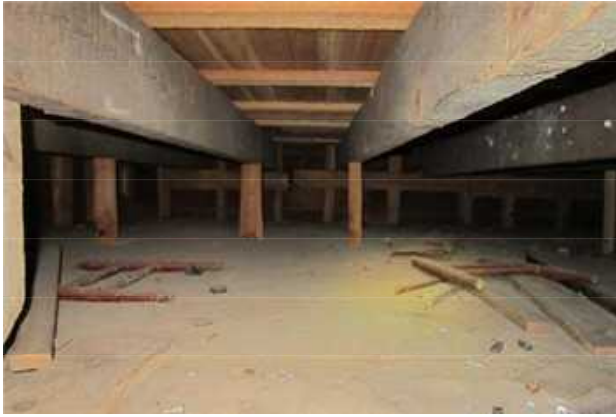
The light roof framing appears in sound and dry condition with limited instances of localized splitting. It was noted that the roof rafters tie to each other in pairs at the ridge with no ridge board and that there are only two collar ties in the attic. The roof framing also supports the original flat plaster ceiling and a newer acoustical tile ceiling with 1x wood boards side nailed into the rafters and attic joists at their 1/3 points. A curiosity in the attic is a pair of heavy hewn timbers spanning across the middle of the main hall which until recently supported a brick chimney. A makeshift truss and reinforcing iron bars were installed apparently after the original chimney construction as a hole in the original plaster ceiling that allowed for the passage of the stove pipe seems awkwardly placed with the steel tie between it and the chimney location. The chimney itself has been removed and there is no way draw a conclusion about the actual location of the original (or later) stovepipes. An engineering analysis shows the roof is undersized for the snow loads it must carry by code, but the steeply pitched roof has seemingly performed acceptably to date.

The stage and privy addition to the rear of the building are later additions to the Center Harbor Town House. The stage platform is made of recycled vertically sawn 2x10s that clearspan from the original rear wall to a recycled sawn beam at the stage front. The beam and many of the joists are supported intermittently with short wood pieces standing on the original floor. The engineer identifies the limited support of the stage floor without regard to the main level framing as a cause for concern. The small privy seems square and well-built but no evaluation was made of its inaccessible frame.

Wall framing and roof framing in place is generally in good condition. The structural engineer has determined that the roof framing would generally be capable of carrying code required snow loads with the addition of collar ties and gusset plates in the main block. 2x6 collar ties should be installed across rafter pairs in the attic connecting to the rafters just above the vertical ties supporting the ceiling. Plywood gusset plates should be cut to match the roof profile and face nailed to the rafters where they meet at the ridge. In the wood shed addition, new 2x8 attic joists should be installed at the tops of walls to prevent roof spreading.

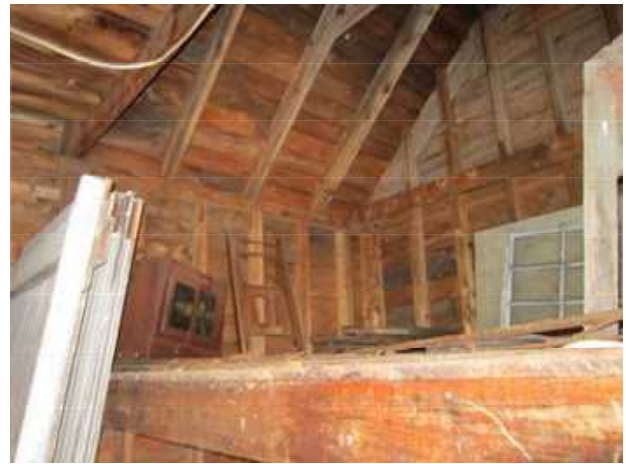
The woodshed addition is constructed of light balloon framing in a slightly different manner than original Town House. 2x4 wood framed walls stand directly on the stone foundation instead of on a wood platform. Two independent wood floor systems are framed with 2x floor joists spanning east to west across ledger boards on the north and south walls. On the south side, a floor aligns with the stage floor and an attic floor bears on the walls top plates above. On the north side, a floor is installed about half-way between these levels. The roof of the woodshed is framed with 2"x7" roof rafters with a 2x ridge board and few collar ties, all in sound condition.

This roof is also calculated to be undersized to meet current code requirements for loading and sheer stresses.

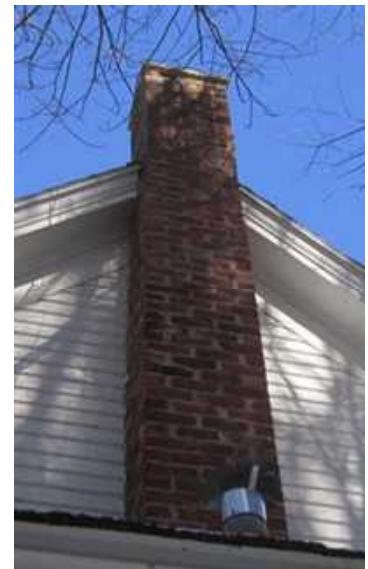
Only one chimney remains of the two previously extant in the Center Harbor Town House. The one-flue chimney of brick masonry appears to have been previously repointed with fair results. A small stone cap adorns the chimney top and there is no interior sign of water leakage, though the chimney itself is completely hidden within the building. Built to serve the woodstove in the main hall, the chimney may not be lined as would be required to be able to continue its original purpose.

The original chimney stood on the roof frame at the center of the main block and a woodstove here tied into the chimney above the ceiling line. Chimneys are often a source for moisture infiltration through a building's envelope and demolition of the abandoned chimney above the roof occurred prior to the last re-roofing. The remaining portion was removed very recently. A large quantity of stone materials in the crawl space at the center of the building might once have composed an

While it appears from the ground that the existing chimney has been previously repointed, the pointing work appears to have over-filled the masonry joints or been trying to repair spalled bricks with mortar. The work in place should be inspected for new cracking or spalling and any problems found repaired appropriately.

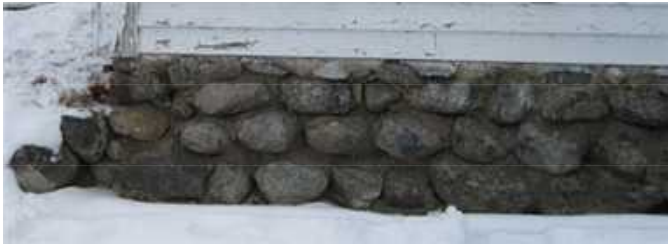
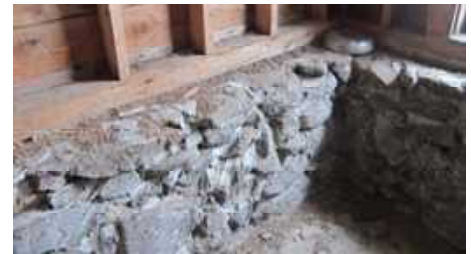
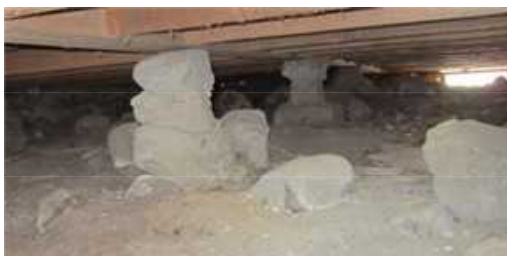
The foundation of the Center Harbor Town House is entirely composed of small to medium fieldstone likely laid to a depth of less than three feet below grade. All of the stonework is in fair to good condition. The stones of the main block were originally dry laid but these walls were later pointed with mortar at the exterior side only, likely because of the inaccessibility of the

crawl space. The foundation of the wood shed addition was constructed with full bed mortar setting and is in good condition and as seen from both sides. Foundations of fieldstone are prone to moving under frost action, but there is only limited evidence of such movement here, predominantly found in the north foundation wall of the main block near to the east building corner. Interior plaster damage at each side of the south facing bank of windows in the meeting hall indicate some additional foundation movement at these locations along the bearing wall. The privy foundation seems similarly constructed to the woodshed wall, but this foundation is only minimally exposed and visible only from the exterior.

The piers at the interior of the crawlspace were also inaccessible, but observation from the locations of the limited vent spaces in the perimeter foundations reveal that these are the weakest components in the foundation system. These piers serve to support the beam floor beams that span north to south across the crawlspace and are typically composed of two or three stones stacked together. Because there are no footings for these piers below grade, they are the most subject

The engineer has commented that replacing the building's fieldstone foundation with a new reinforced concrete foundation would be a very expensive approach to bring the building's foundation up to the requirements of a new building. Because the existing foundation appears stable, he does not recommend any substantial upgrades to the existing foundation. This outlook is completely in line with preservation Standards for Rehabilitation, which would seek to maintain the fieldstone foundation, a Character Defining Feature of the Center Harbor Townhouse. An area of the stonework at the northeast corner should be rebuilt to properly support the corner of the the frame. Adding two feet of rigid insulation buried below grade at a 45 degree angle could help to protect the likely shallow footings against the kind of frost action that has affected this small portion of wall. The rest of the exterior walls should be inspected and open mortar joints re-pointed. Any openings in the walls large enough to allow animal entry to the building should be completely filled.

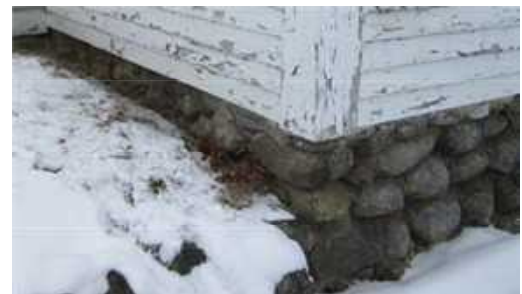
to movement under frost conditions. Some are raising the floor beams higher than necessary and introducing curvature to the floor above, and others fail to even support the beams at all, leaving air gaps under their intended bearing points. Four vents into the crawlspace are provided with fixed louvers, removal of which does not allow an adult to enter the crawlspace. No standing water was observed in the crawl space, though the proximity of soils to the building floor frame is a concern. Grades around the building appear to pitch more than the minimum of 3" in six feet that would be desirable.

At the foundation level, there are significant additional challenges with the building structure that need to be addressed: moisture in the crawl space and frost action under the building's central piers. The following recommendations should greatly improve the building's current moisture problems. In the crawl spaces, all soil within 18" of the wood frame should be removed by hand (8" +/-). A vapor barrier should be installed over the dirt floor of the crawlspace, taking care to allow for a wide overlap and taping of all vapor barrier components under all structural work. Once the ground is covered, vents in the foundation should be rebuilt to allow them to be opened in the late spring and early fall and closed in the remaining seasons.

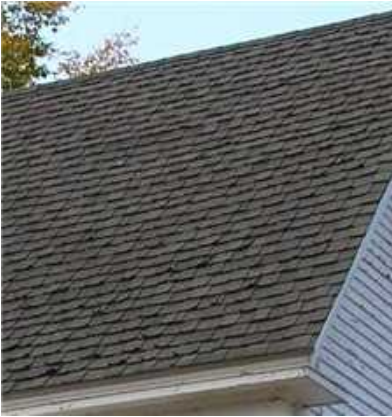
The roof of the building was inspected from the ground and through photographs as it was covered with snow during the season of this investigation. The architectural asphaltic shingle roof is reportedly fifteen years old and is showing signs of localized curling with no failures of performance noted at the interior. The patch made where the chimney was removed is well done and not readily observable from the ground. The type of roofing installed is capable of providing good protection for an extended period of time, but can be affected by building movement, wind damage, and poor installation techniques. The cupping of the shingles is concerning and should be watched carefully.

Keeping water out of any historic structure like the Center Harbor Town House is always a high priority and it seems like the architectural asphalt shingle roof has been doing that job well. Excessive curling of the roof shingles may be indicative of premature failure of the roofing system. The main roof and those of the additions should be inspected by a qualified roofer and any damaged materials replaced. Extra attention should be paid to the likely locations of failure around roof penetrations (like the chimney), the valleys, and any areas of previous repair such as where the central chimney was previously removed. The roof's ridges, eaves and any horizontal joints should also be reviewed.

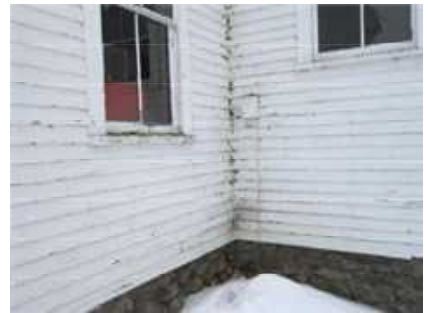
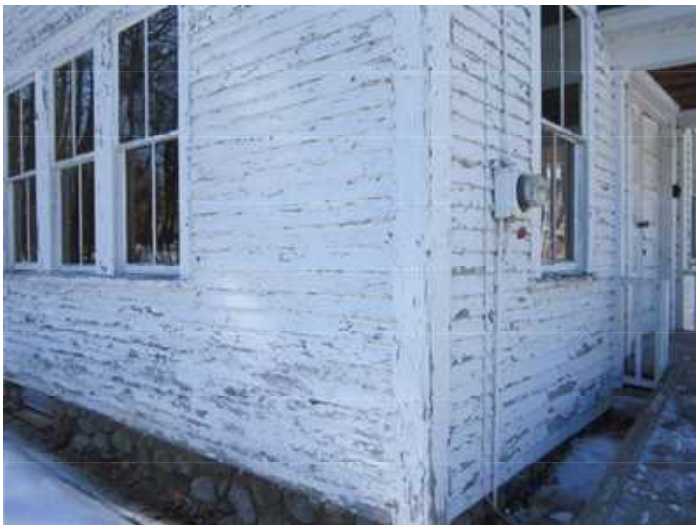
The clapboard siding on the building is generally in poor to fair condition with the greatest degree of deterioration at the interior corner where the woodshed meets the original structure. Additional damage to the clapboard finish is concentrated at areas near the lower portions of the walls where splashback from roof stormwater repeatedly wets the wood. Additional damaged materials may be found with additional inspection in areas where roofs and the chimney meet sidewalls of the west side of the original structure. Inspection from the ground did not reveal problems in these areas.

The paint finish on the exterior is in poor to extremely poor condition, with paint failure a primary concern on the north, east, and south elevations of the main block and woodshed addition. The west façade is in better condition with fewer complete paint failures. At large areas of the clapboard siding and trim, paint is heavily peeling with substantial areas of bare wood visible. Paint is peeling off in large flakes and falling on the soils around the building, a concern because all paint applied prior to the mid-1970s is likely to contain lead, a known hazardous material with special state and federal handling requirements.

It is preferable to retain existing siding material and remove damaged paint finishes than to replace the siding wherever possible. On all areas of the north, east, and south elevations of the building where paint is peeling to bare wood, remove all remaining existing paint by hand and apply a quality latex primer and two coats of finish paint. On the west side, where the existing paint condition is better, painting preparation should be as appropriate for localized conditions. Painting in fair to good condition should be lightly sanded to assure that new paint binds adequately to the

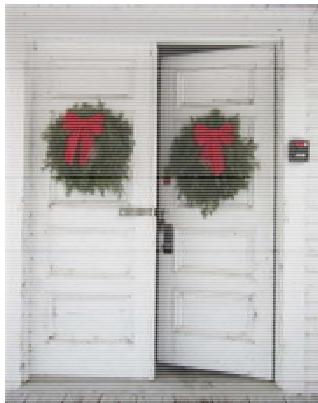
Paint on doors and windows is in mixed condition, generally similar to that of the clapboard finishes on the same facades. The window glass in the window at the rear of the stage north of the privies has been broken and temporarily secured with a plywood cover on the exterior. The paint on the double entry doors and trim is in fair condition as these doors are protected from the weather by the porch roof. Paint on the lower panels is in worse condition and has started to peel at the left side.

Paint finishes on the Center Harbor Townhouse should be undertaken with care appropriate to specific conditions identified elsewhere in this report. The age of the building indicates a very high likelihood of lead paint being a part of the failing paint and appropriate steps should be taken in the removal of lead paint according to state and federal standards. All trim and decorative wood on the Town House should be retained, as should the wooden windows and doors. Heavily damaged wood should be repaired with an epoxy consolidant after paint removal and before repainting. Window sash should be removed and refurbished, not replaced, and the window at the west (back) side of the stage should be reglazed. The exterior doors with missing panels should be fitted with new panels to match the original intent. The entry door with the cracked or split bottom panel should be repaired.

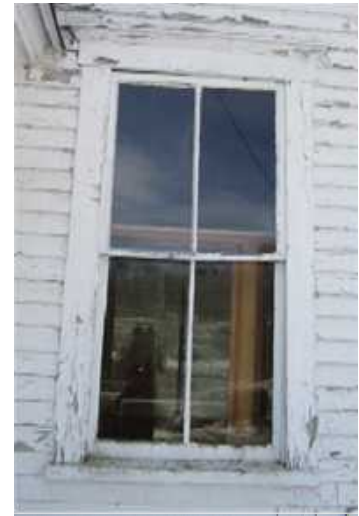
The door to the woodshed addition is served by no entry step though it's sill is approximately three feet above the grade and four feet above the concrete floor at the interior. Two of the five panels in this door have been replaced with hardware cloth, perhaps as an aid to drying the fire wood that was once stored here. Similarly, the double hung window adjacent has been fixed in place with the upper sash open and the opening infilled with hardware cloth. Window glazing putty is in fair conditions with limited failures.

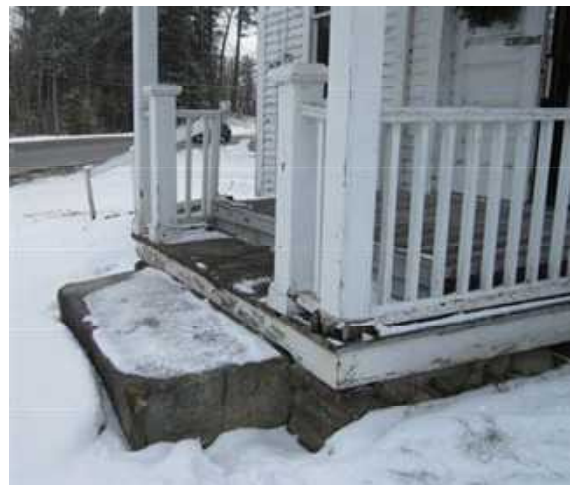
The floor of the entry porch and the bottoms of the decorative posts that support it the porch roof are suffering from structural deterioration as well as finish failures. The shallow porch frame is even closer to the soils beneath than is the floor of the main block to the crawlspace dirt and is therefore exposed to even higher levels of continuous moisture. Compounding that, the porch floor is laid to allow water through the porch floor deck, but the space below the porch is closed in at the porch perimeter with stonework. The addition of the ad-hoc handicapped accessible ramp over the top of the porch floor all conspire to allow moisture into the cavity beneath the porch and then trap it there without adequate ventilation of the space to allow for drying. The porch floor is deteriorating and crushing where it bears on the corner stones and elsewhere. The column bases and lower portions of the railings are suffering from rot as well as paint failures.

The closed stonework under the entry porch has likely contributed to the deterioration of the porch frame. These walls should be removed and replaced with deep concrete cast footings and single stone blocks above grade to support the corner posts. Once the porch floor has been reconstructed, the stone step should be re-set on an 8" minimum bed of 1 ½" stone to a level 7" below the porch floor.

It appears that the entry porch floor and the porch's corner columns require rebuilding because of water damage. The existing molded railings, balusters, and post trim should be carefully removed and set aside. The porch roof assembly is in good condition and should be supported in place while the existing ramp, the water damaged porch floor, and the porch frame are replaced. Use pressure treated pine with painted pine trim for the the porch floor and vertical grain douglas fir with a clear finish for the flooring. Coordinate foundation work described elsewhere in this report to be done in conjunction with the porch repair. Damage to the corner posts may be limited to the decorative base moldings only or may include damage to the structural post as well. To the highest degree possible, retain or reinstall original post materials. Once the posts are secure, fabricate additional materials to rebuild the railings to match the original intent. Regrade across the front of the building to provide good access to the reset stone step at the front of the porch.

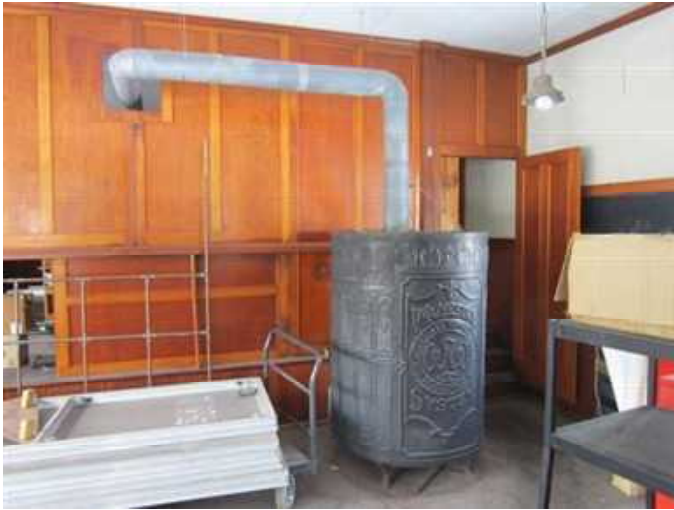
The existing building is furnished with a 1930's vintage Waterman-Waterbury wood stove wrapped in an enormous metal heat shield. While attractive to look at, this stove was reportedly finicky to use even when it was new and is inadequate to meet the heating needs of a modern structure without a major servicing and a dedicated individual to keep it running well. Combustion air is provided to the stove through an intake vent under the window in the west wall behind the stage and through ductwork under the stage. A single-walled stove pipe is intended to carry waste gasses to the chimney at the privies with a horizontal stove pipe two feet or so below the ceiling.

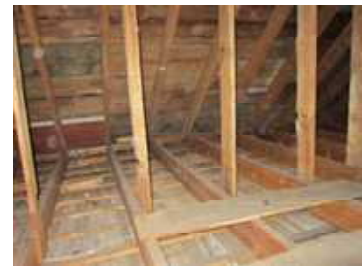
There is no insulation in the Center Harbor Town House anywhere in the walls, ceilings, or floors. The main attic was once ventilated with a single louvered gable vent but this was closed over prior to the installation of the Town House sign on the east gable face. Passive bathroom vents from two bathroom stack vents appear are likely joined in the attic above the privies and vented through the roof in a stovepipe type vent just west of the chimney.

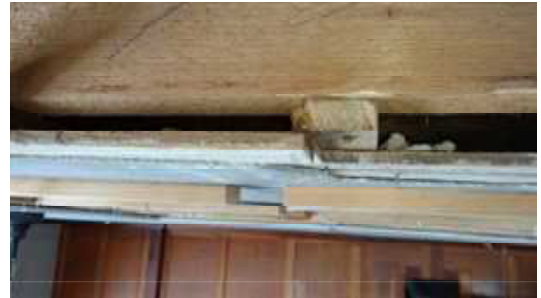
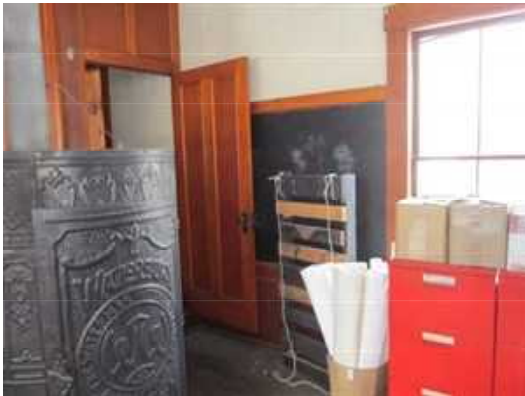
unknown date. This new ceiling was significantly damaged during the recent demolition of the chimney above the ceiling, resulting in an open hole into the attic. The acoustic ceiling is installed on strapping attached to the face of the original ceiling plaster, the condition of which is unknown. Plaster ceiling failure is often an issue in buildings subject to movement on stone foundations and the new ceiling may cover loose or failing plaster. Alternatively, the new ceiling may also simply have been installed to dampen the acoustics in what would be a noisy room with lots of hard surfaces. Either way the original ceiling plaster is likely in poor condition.

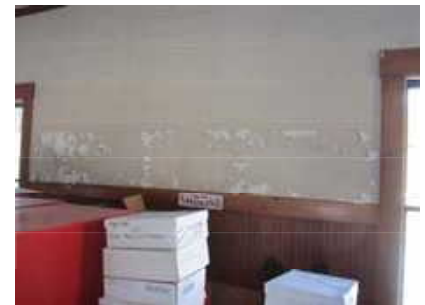
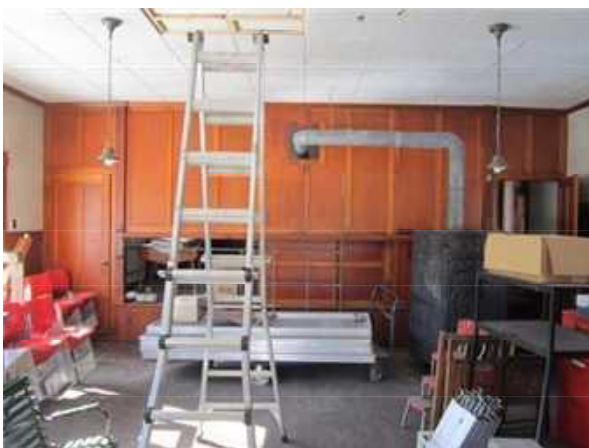
These hard surfaces: the wood floor, the wood wainscot, and the plaster walls above the wainscot all remain intact as they were in 1939. The narrow strip wood floor was covered in dirt and dust and the overall finish may be well worn. The window and door trims and wainscot, where visible, are intact and in good condition. Plaster finishes are generally in good condition with localized failures at the upper corners of the bank of windows on the south wall and diagonal cracking at the northeast corner of the meeting hall. Hairline cracks also appear in the plaster above the

black board installed on the north wall adjacent to the stage door. There is an incidence of dramatic paint failure on the plaster at the north wall between the windows and above the wainscot. Previous replacement of the wainscot cap on this wall and bonding cement on the wainscot indicate that this portion of the wall was once covered with a blackboard or bulletin board, now removed.

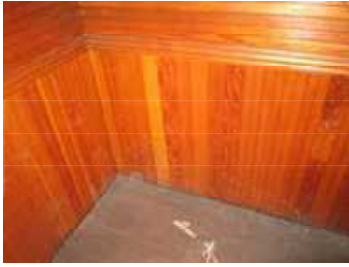
The stage railing has been modified to allow removal of the rail and to support a system of multi-paneled solid wood screens in fair condition. Tall, two panel doors in good condition close off the bottom of three step stairways at each side of the raised platform. Among the articles in the stage area are two uninstalled additional panels which appear to be original components of the wood screen from prior to the installation of the stove pipe. There are signs on the wall that there may have been a panel dividing the stage area in half with the panel end attached at the west (back) wall. The uninstalled panels on the platform may have been built for this purpose instead

or perhaps used for both. The wainscot and plaster finishes in the stage area seem to be intact and in fair to good condition. There is marked cracking in the plaster above the doors probably relating to the infill patching of these areas where windows were replaced with the five panel doors. The makeshift kitchen without running water at the southwest corner of the stage area is poorly made and unrelated to the historical aspects of the Center Harbor Town House.

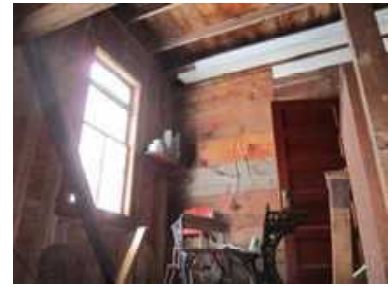
In the two privies, the wall and ceiling finishes are all the original narrow beaded board wood oriented vertically in a wainscot and horizontally above. The lacquered wood in good condition. The floors of narrow strip wood are very dirty and likely in need of refinishing. The storage cabinet in the ladies room is also original and in fair condition. The

later addition, the wood shed, is completely unfinished. Although quite dusty, this space retains its rough, original character.

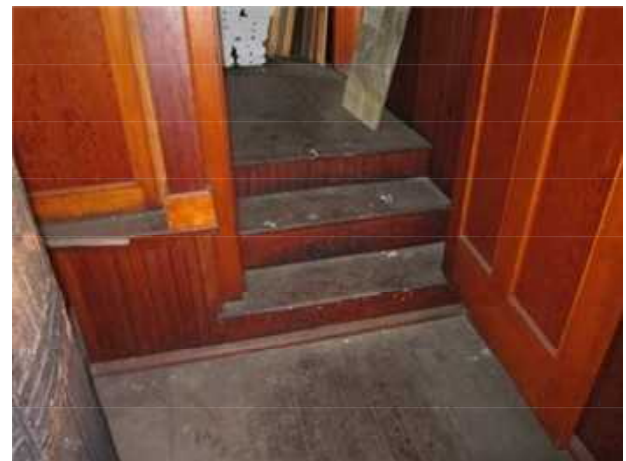
with the requirements of the code, but there are elements of concern that should be noted. Most notably, the building only has a single means of egress: a pair of front entry doors. Technically, each individual door is too narrow to meet egress requirements, but their historical value and lack of closers should make them acceptable. Although there is a second door out of the wood shed addition, that door is not accessible from either the exterior or the interior as there are no entry steps on the outside or floor on the inside of the door. A single exit is permitted in an assembly space when it opens directly to the exterior, but occupancy in the space is limited to fifty people. With the stage area closed, required egress from the stage area is not directly to the outside but instead through other spaces. This is a significant hazard. There is no automatic smoke or fire alarm system in the building and no sprinkler. The absence of both could be catastrophic in a fire event where the town must rely on any problem becoming significant enough for passerby to notice and call the fire department. While not a life safety issue, the broken window at the rear of the stage indicates that a security system for the building may also prove useful. Vandalism may be additionally protected against with the installation of Lexan storm windows, which would also afford weather protection for the historic wood windows.

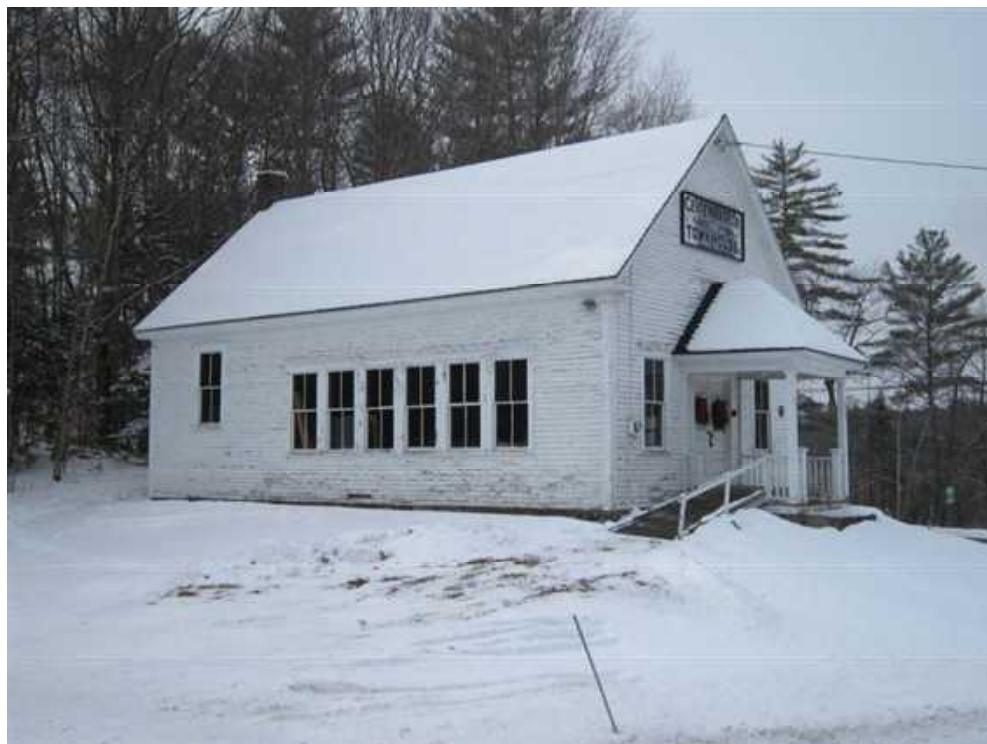
Center Harbor Townhouse as it stands today.

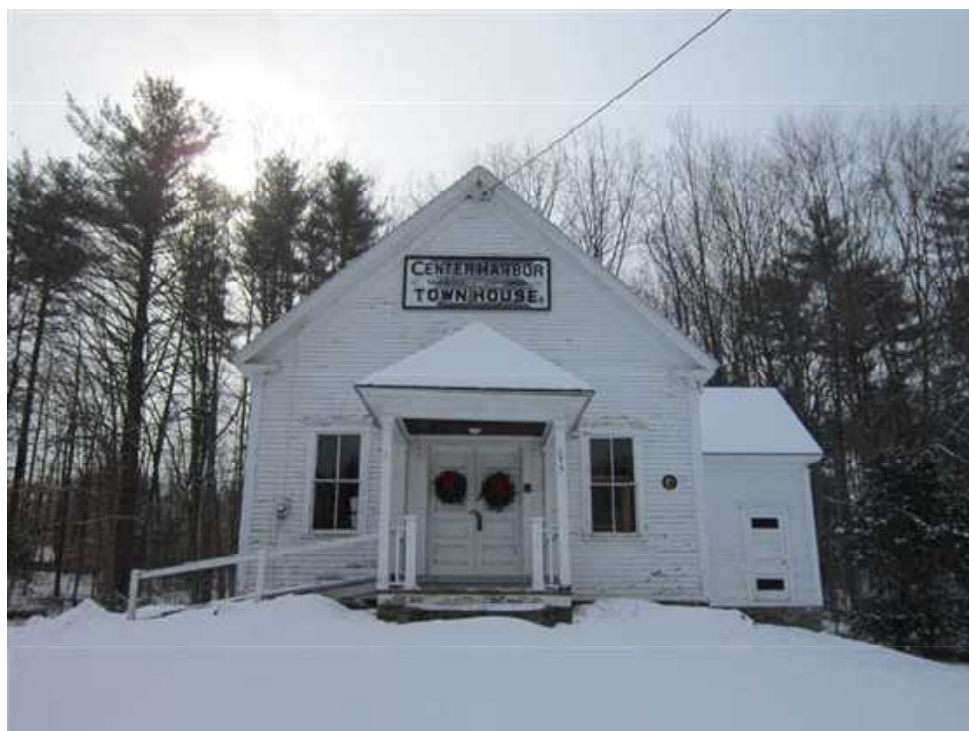
East elevation of Greek Revival Center Harbor Townhouse showing 2/2 windows and entry porch

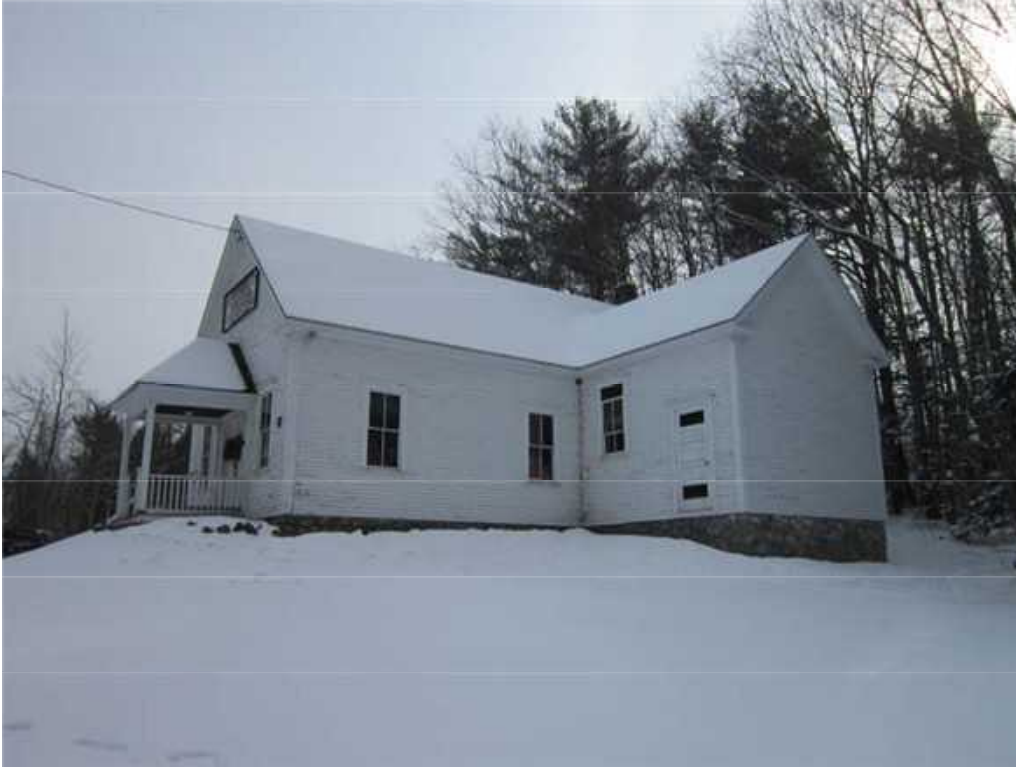
North side elevation showing strong relationship to ell. Note window of woodshed is placed at level of stage

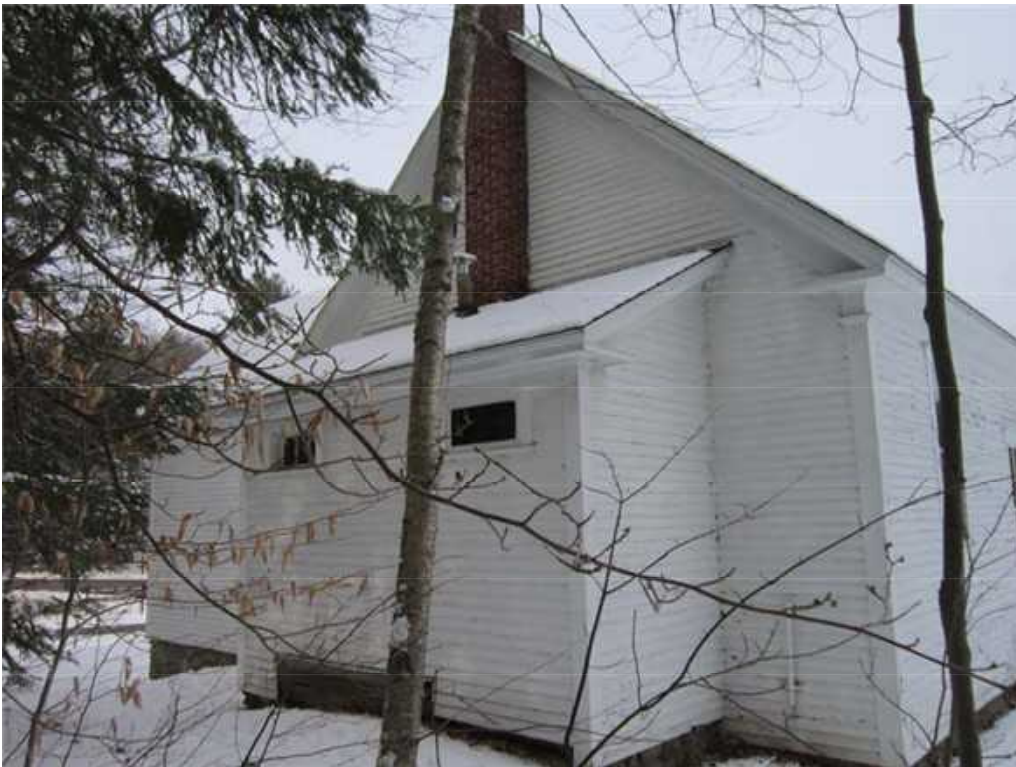
West end of main block showing Privy addition at rear of raised platform and chimney

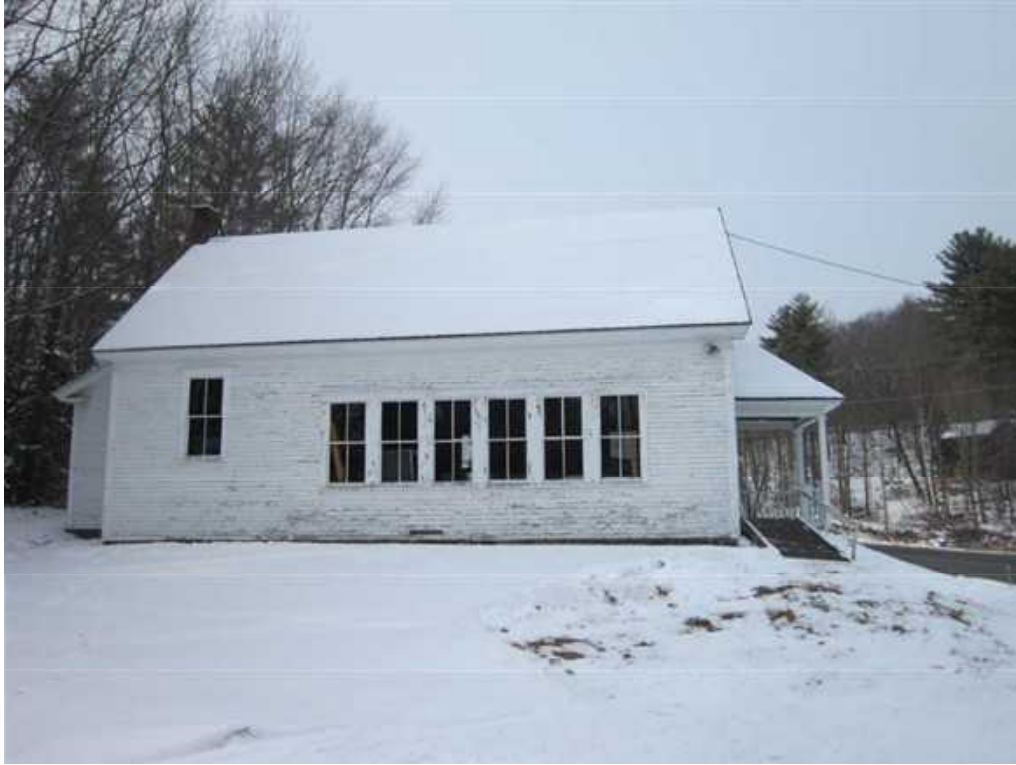
South elevation of main block with the privy seen to the left and the entry porch on the right side with its overlaid non-conforming ramp.

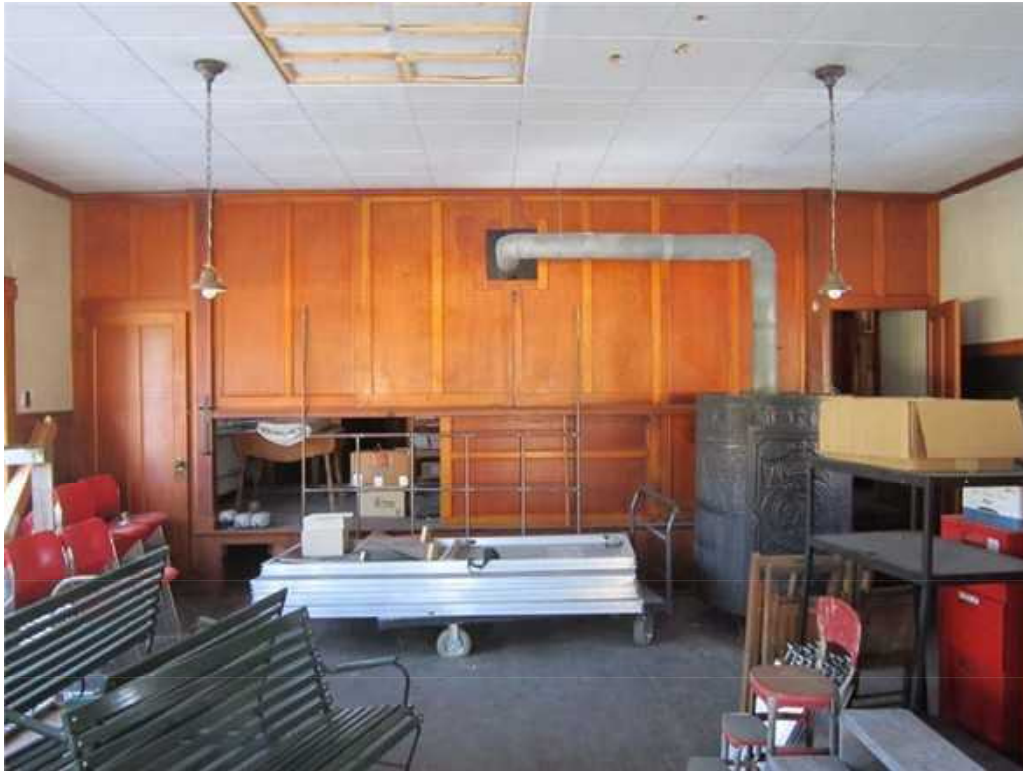
Interior of hall with removable solid panels on the railing separating the stage area

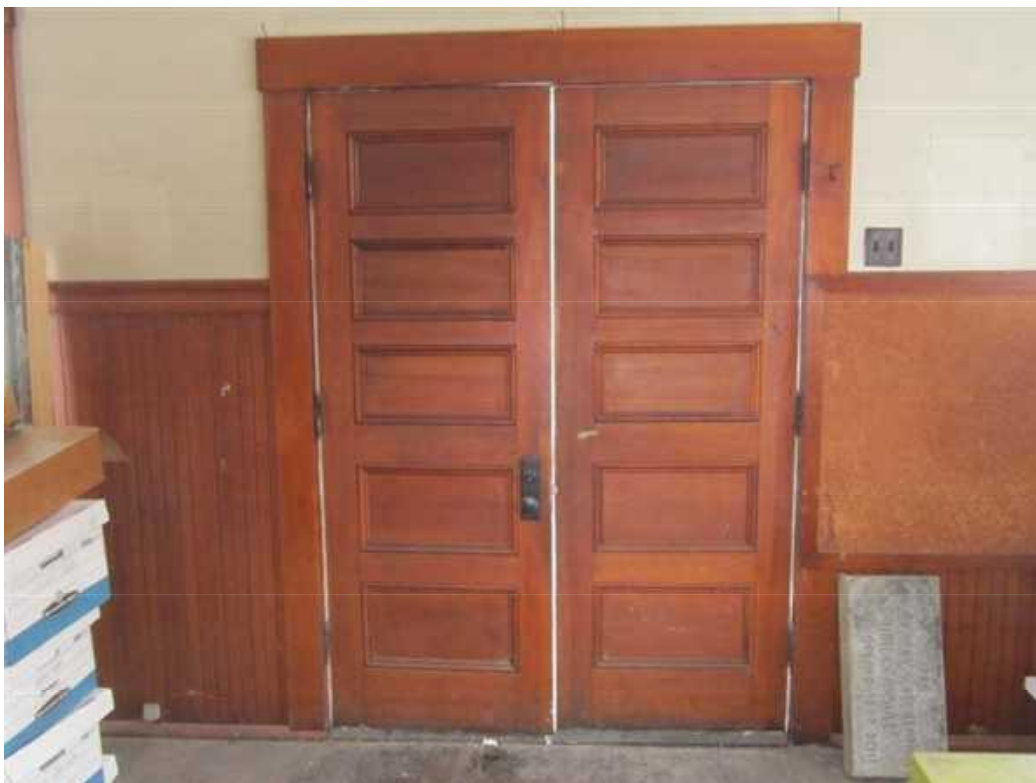
Interior side of 1907 double doors

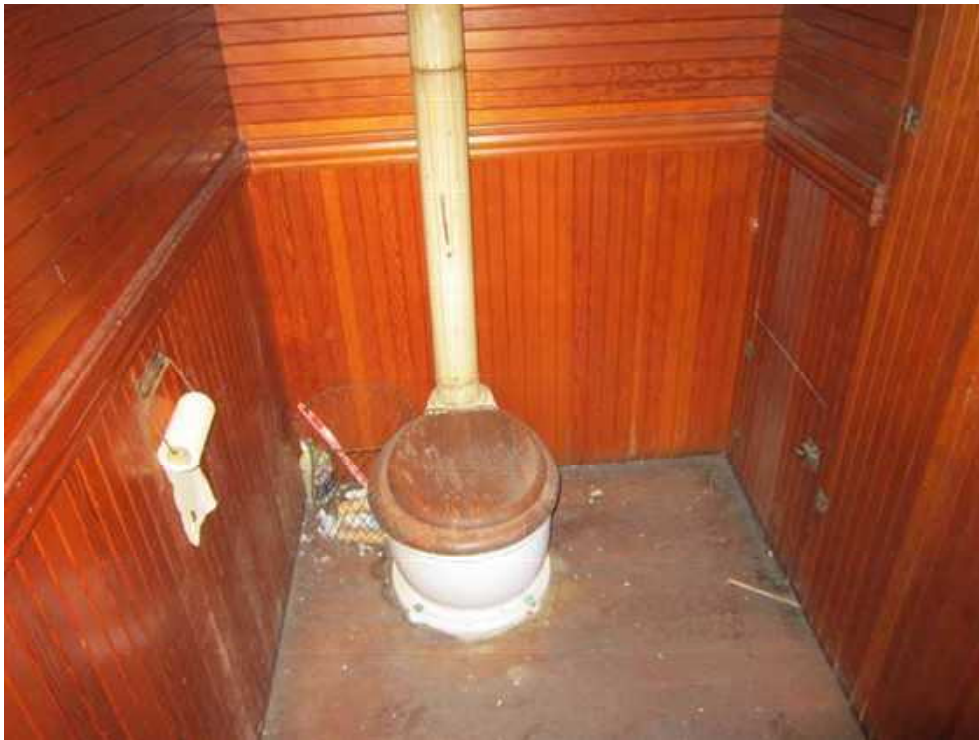
Privies are no longer working. Note that no plumbing in this bathroom impact the original wall finishes.

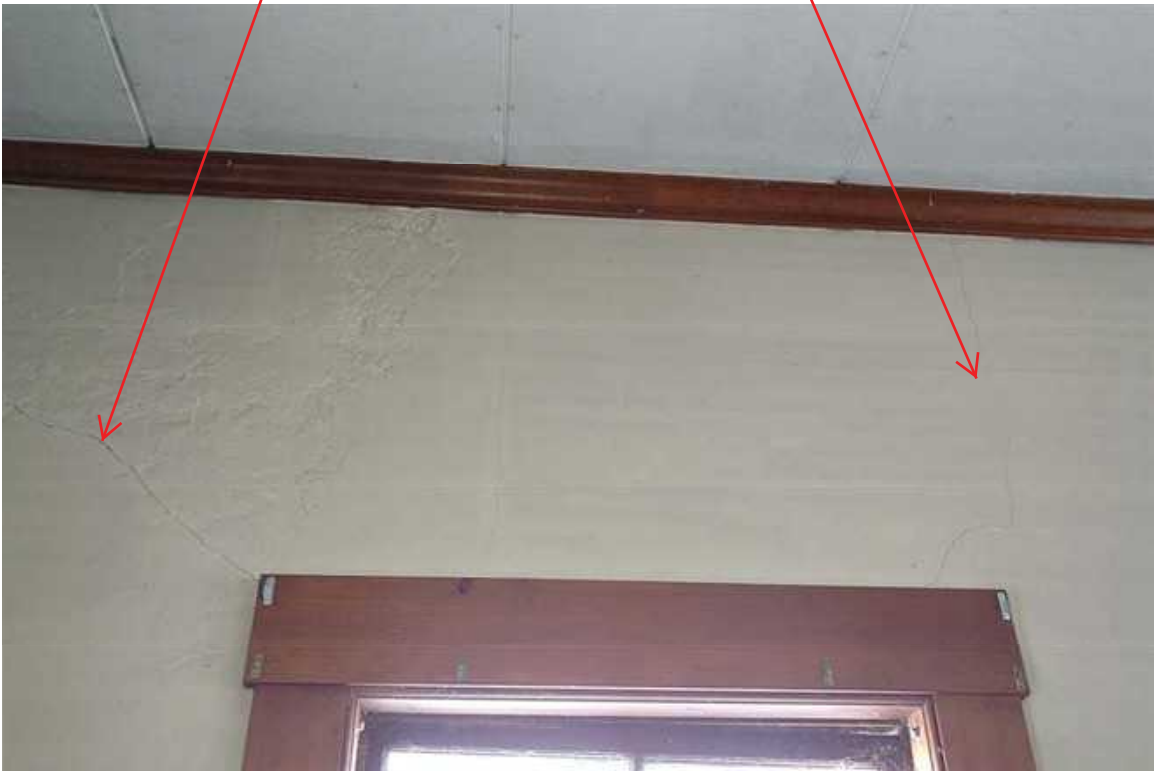
Minor cracks in plaster  
indicating foundation movement
